# *Solid Foundation Home Inspections of NJ, LLC*

## Property Inspection Report

2305 Tall Street, Anytown, NJ 12345  
Inspection prepared for: Johnny Homebuer & Wendy Homebuyer  
Real Estate Agent: Jane Realtor - Best Realty Company - Basking Ridge

Date of Inspection: 12/24/2016  
Inspection# 21612-5555

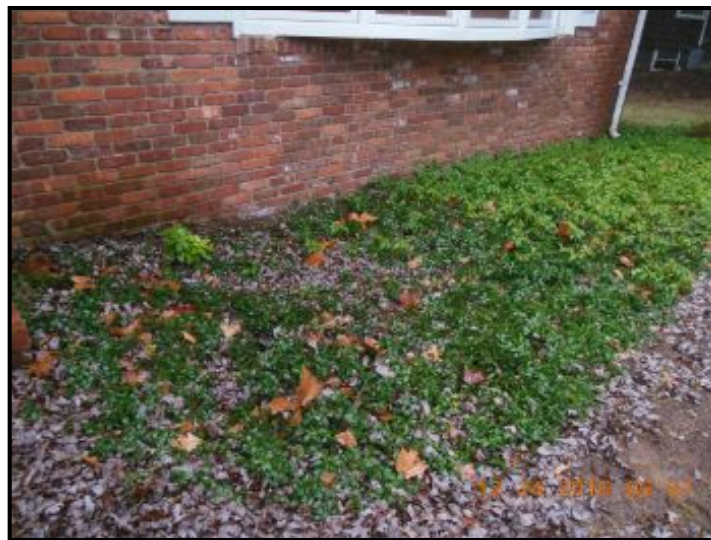
• **Defective.** Settled areas were noted next to the foundation at several different locations around the homes foundation. Lot grading and drainage have a significant impact on the building, simply because of the direct and indirect damage that moisture can have on the foundation. It is very important, therefore, that surface runoff water be adequately diverted away from the home. Lot grading should slope away and fall a minimum of one (1) inch every foot for a distance of six (6) feet around the perimeter of the building. This condition will cause water to drain in this area leading to moisture seepage through foundation wall. Recommend contacting a qualified landscape contractor to backfill all low lying areas to create the proper slope away from the house to allow for effective drainage.

Grounds are settled significantly at front side of home

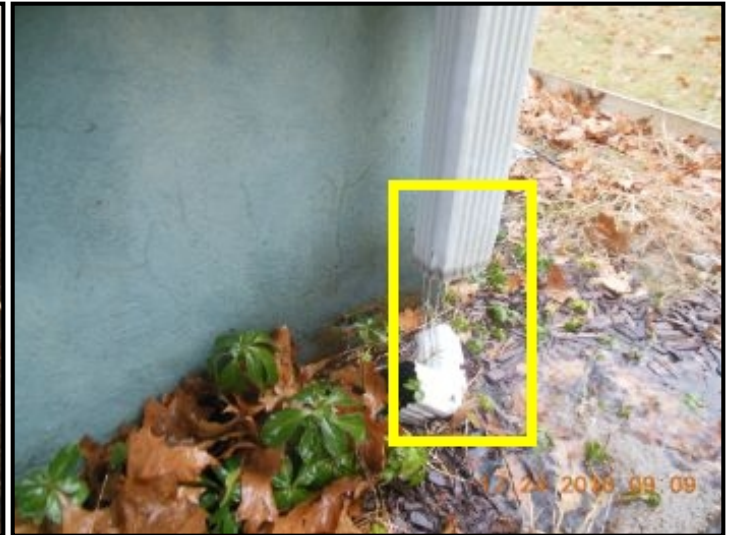
Downspout is draining next to foundation walls

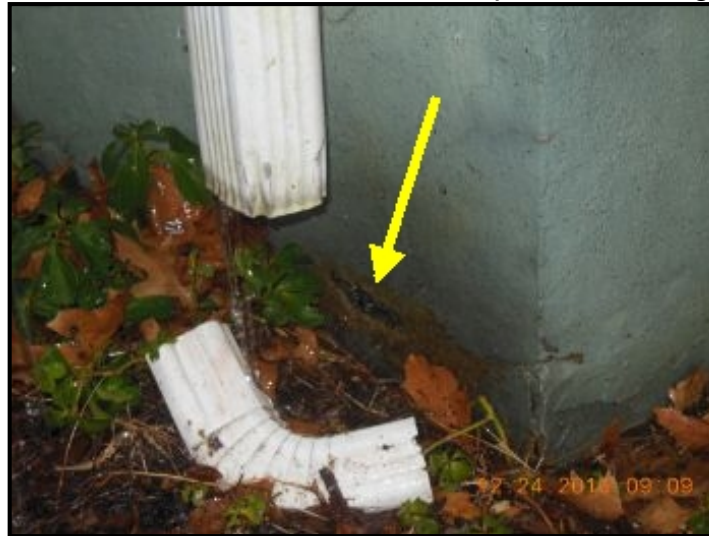
Minor erosion damage was noted on foundation wall from improper downspout drainage

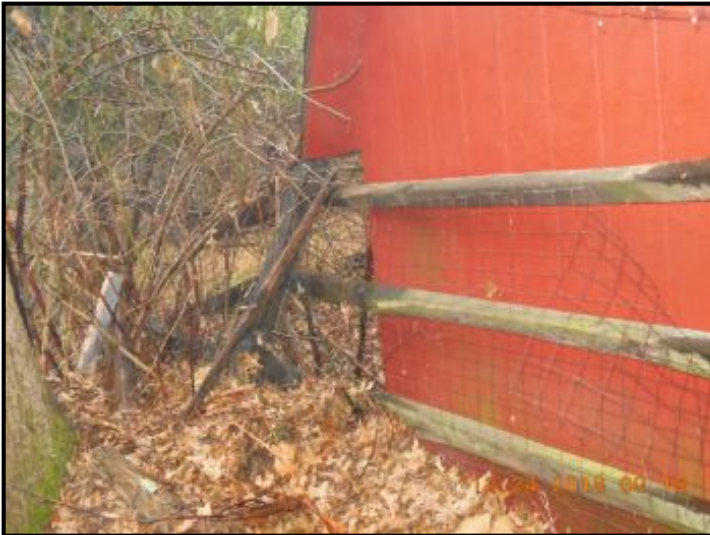
- **Hazardous. Extensive damage was observed to fence around pool in yard. This condition can be a safety concern for young children in the neighborhood as children can wander into yard and drown in pool. Recommend contacting a qualified fence contractor to replace fence around pool with gates approved by township as necessary prior to close for safety.**

Extensive damage noted to fence around pool

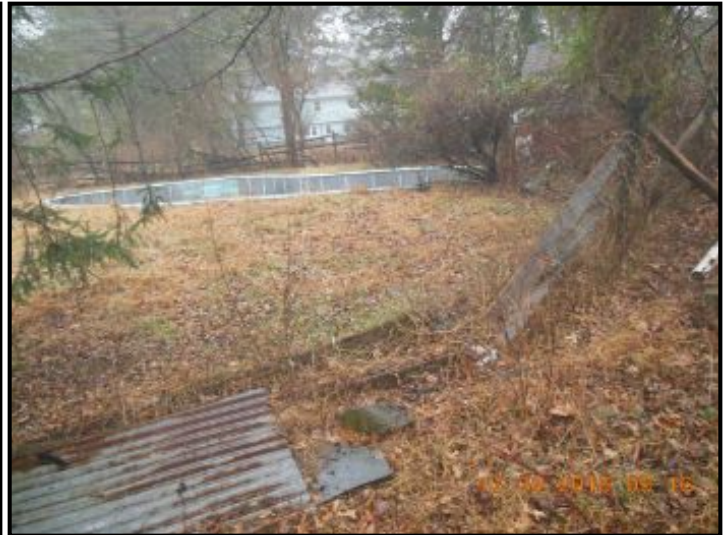
Fence around pool is collapsed

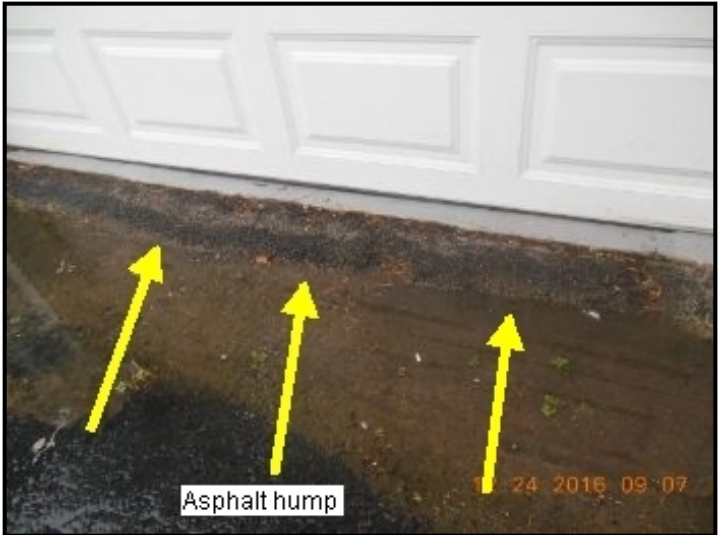
• **Repairs Needed. Two large puddles of water were observed at front of garage vehicle door. These two puddles will be slippery in winter freezing conditions. It appears water is draining towards the garage. An asphalt hump has been installed at front of garage floor to prevent water from draining into garage. This hump can make entry into the garage difficult and can prevent high vehicle (SUV, truck, etc.) from entering garage. A drain should be installed in front of garage to prevent water from collecting in front of garage. Recommend removal of the asphalt hump and have underground drain installed at front of garage by qualified asphalt driveway contractor as necessary prior to close for easy access into garage and to prevent water from draining into garage.**

Water collects in front of garage vehicle door with hump of asphalt installed to prevent water leakage into the garage

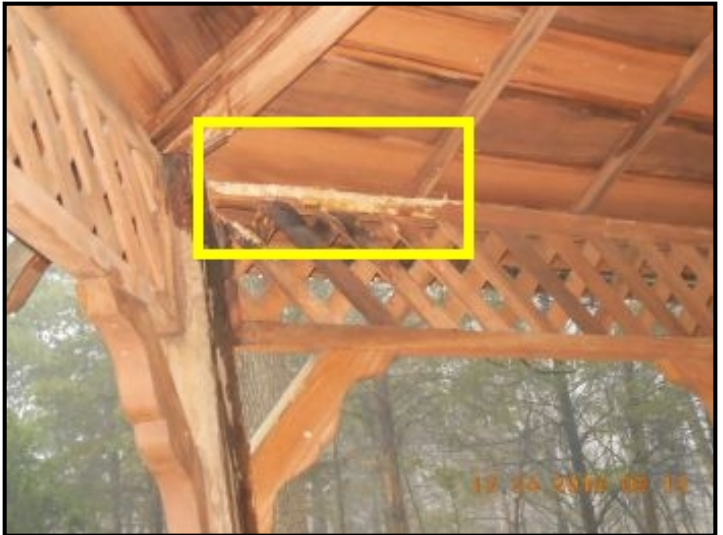
**• Recommendations. A detached gazebo is installed on the property of this home. Structure was reviewed and some minor rodent damage was observed inside gazebo under roof. This damage does not affect structure at this time. If client is concerned, recommend having gazebo reviewed by qualified building contractor for his/her recommendations prior to close.**

Rodent damage noted to gazebo structure under roof

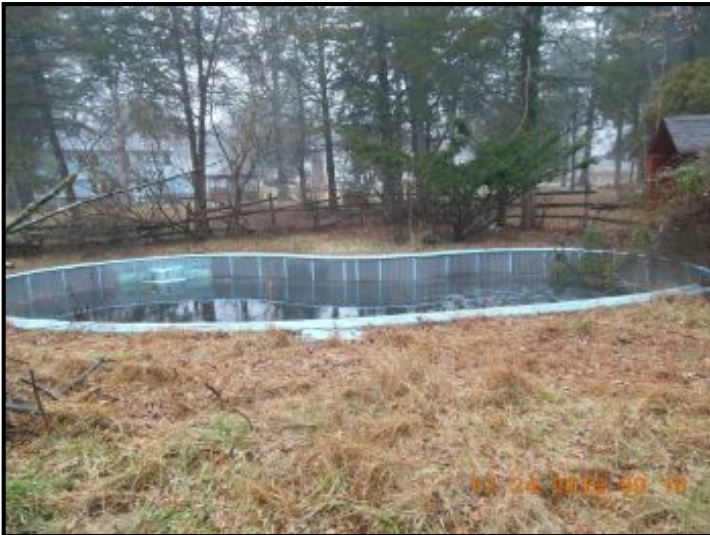
Underground pool is in poor condition

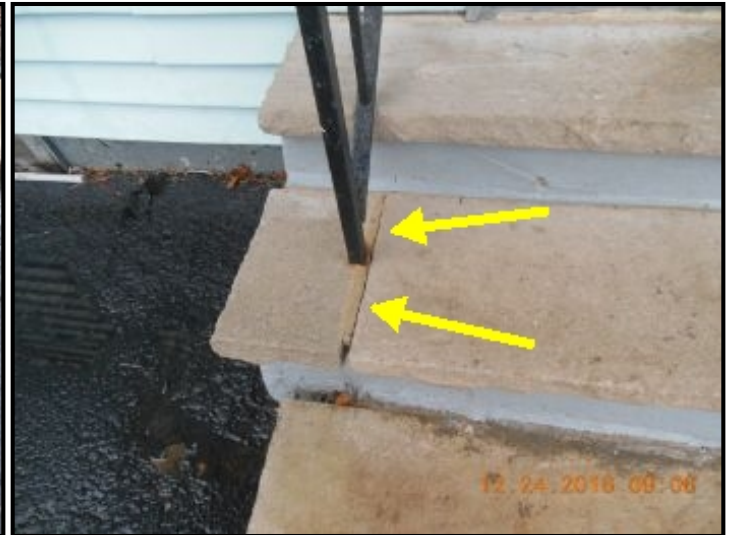
Open cracks in mortar joints on concrete steps

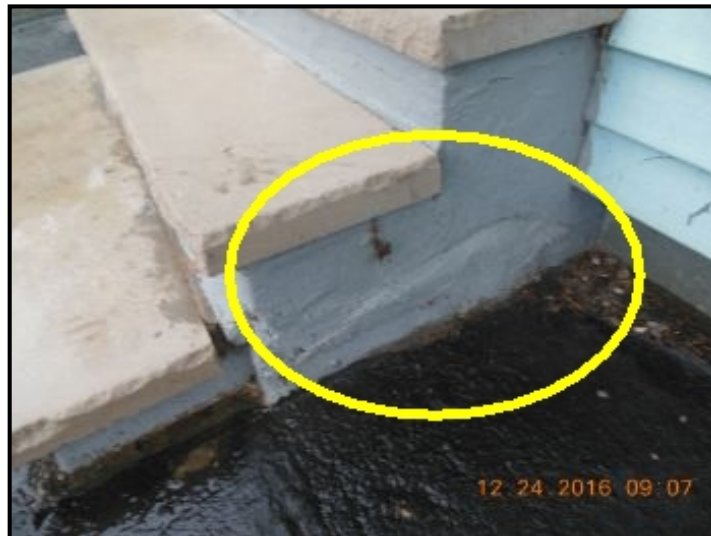
Swollen concrete stucco noted on side of porch indicating damage

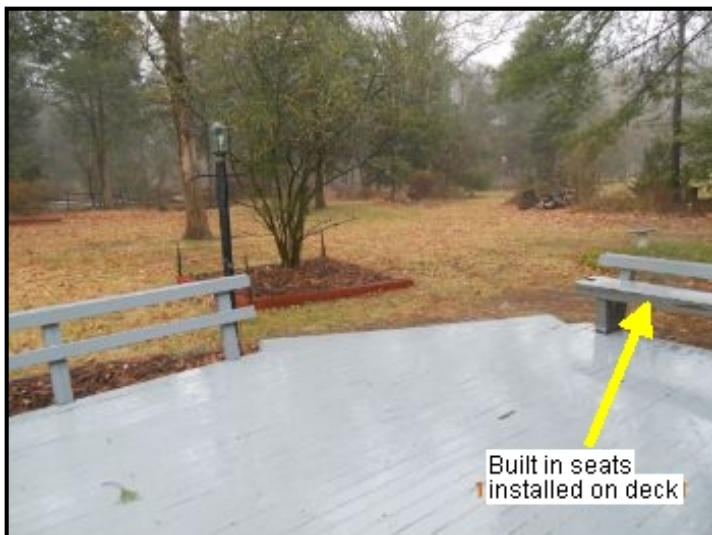
**• Hazardous. Built in seats are installed on deck. The seats can be a possible safety concern as children can climb seats like a ladder and fall to ground causing injury. Though not required for resale of home, client should consider either removal of seats or installing railings 36" high at back side of seats to prevent children from jumping off deck. Recommend removal of seats or installation of railings above seats 36" high with vertical guardrails spaced 4" apart as necessary for safety enhancement.**

Built in seats noted on deck

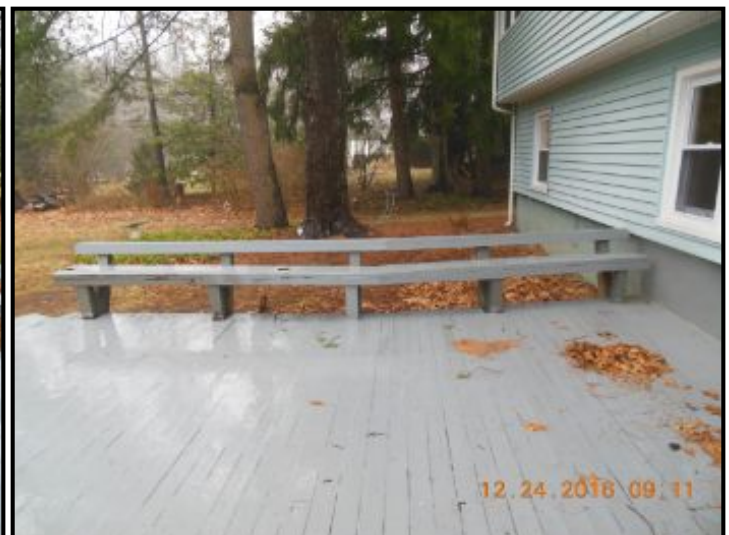
Built in seats installed on deck

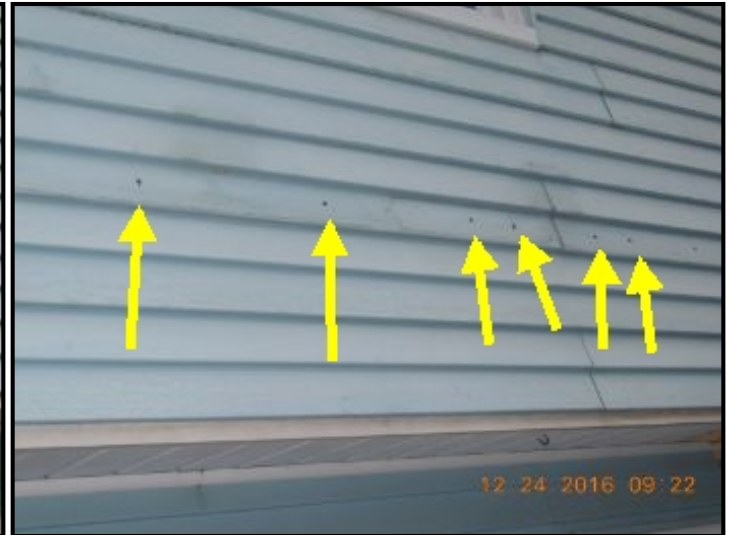
Open holes were noted in vinyl siding from removed deck awning cover

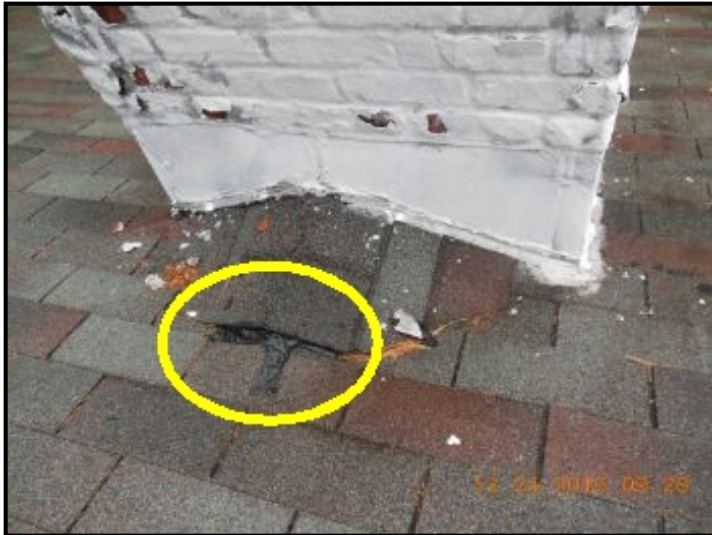
Roof cement repairs noted

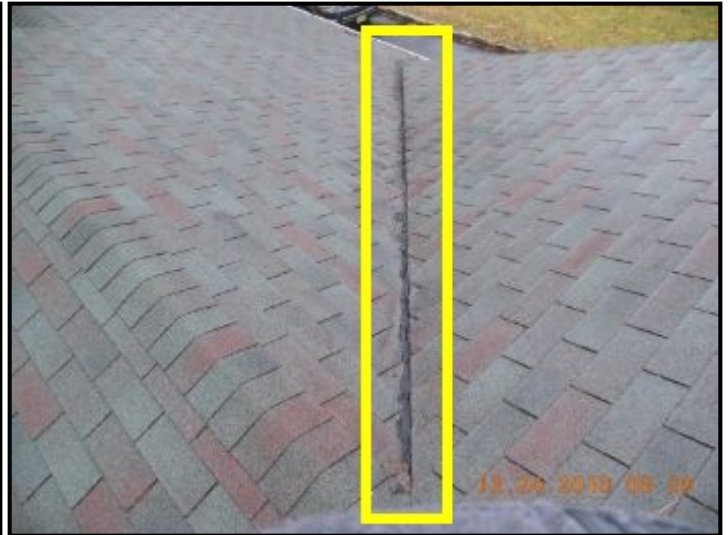
Roof cement repairs noted in one valley

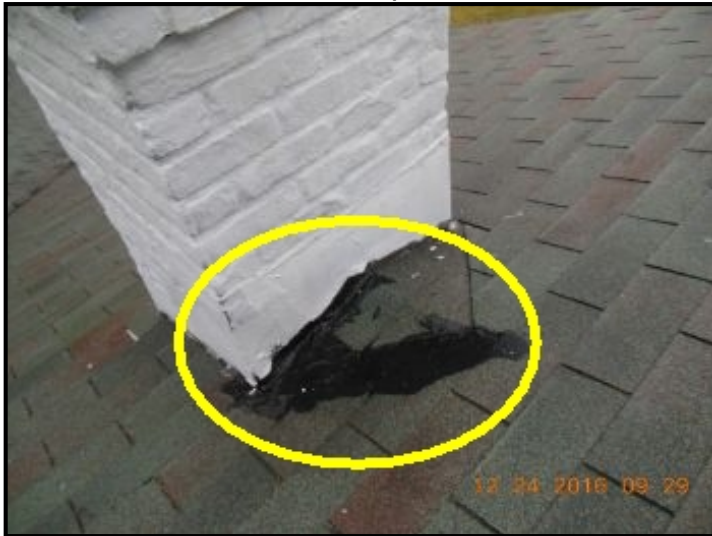
Roof cement repairs noted at cricket above the heating system chimney

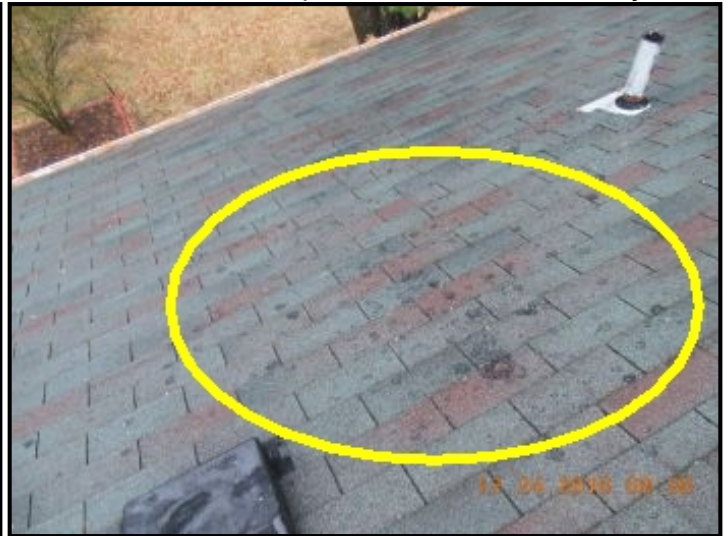
• **Repairs Needed. Roof shingles are weathered and beginning to curl up on edges indicating shingles are at the end of its useful life. Some worn and defective batches of shingles were observed on rear roof. Several roof cement repairs were observed at crickets behind chimneys and along one valley on roof. Repairs of this nature generally indicates previous leakage conditions in these areas from poor or improper installation. Roof cement repairs are considered temporary needing periodic repairs. Evidence of leakage was observed by wet sheathing in attic at front side of fireplace chimney. Recommend contacting the present homeowners for information regarding the need for repairs and a qualified roofer to review patched area of roof for his/her recommendations and repairs as necessary prior to close to prevent further leakage and damage to home. Client should be aware that, due to conditions and age of roof, replacement will most likely be necessary within the next five years.**

Some worn damaged batches of shingles on rear roof

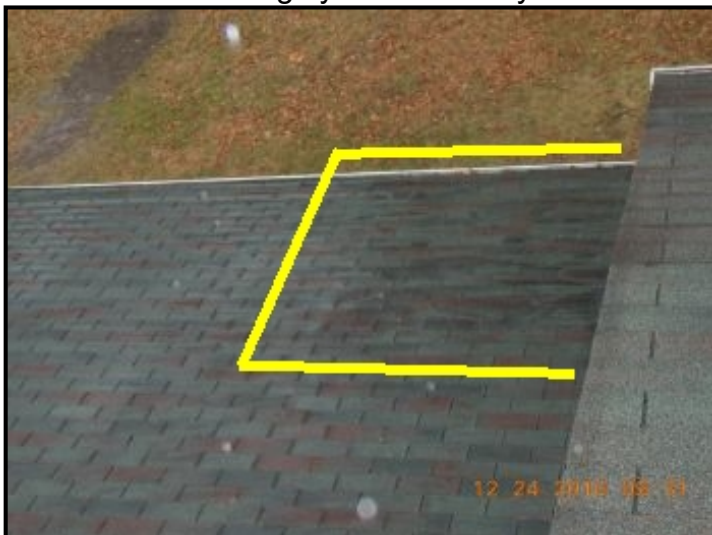
Heavily weathered curling shingles noted on rear roof of garage

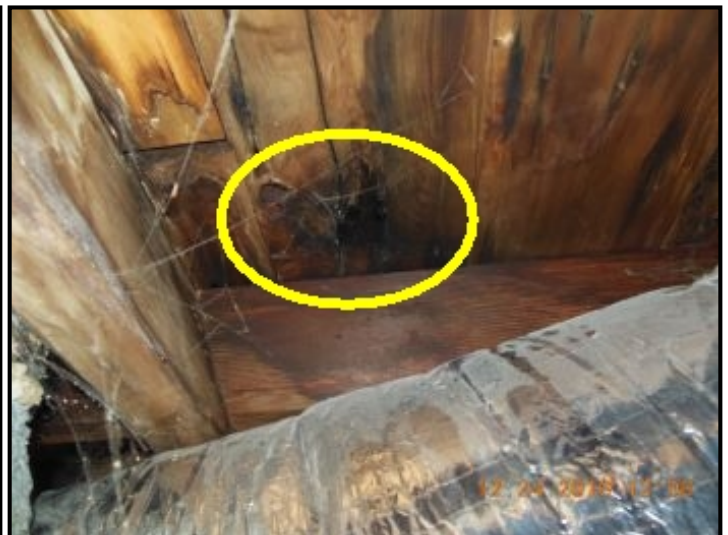
Active leak noted in roof by wet wood and dripping water

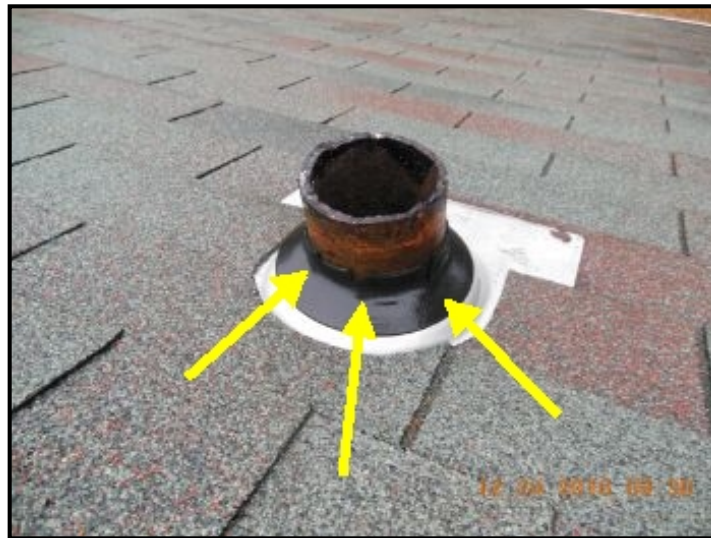
- **Defective. Cracks/openings were noted at the plumbing vent pipes collars leaving wide open holes for leakage. It is always recommended to replace all vent collars when one is replaced as all collars are at the end of their serviceable life. This condition is a water leakage concern. Recommend contacting a qualified roofer or siding contractor to replace plumbing vent collars as necessary prior to close to prevent moisture damage to home.**
- **Repairs Needed. Evidence of leakage was observed in attic by moisture stains and wet plywood sheathing. Inspector is not able to determine if leakage is coming from chimney flashing and/or chimney structure. Recommend contacting a qualified roofer and/or chimney contractor for repairs as necessary prior to close to prevent further moisture leakage and damage to home.**

Cracked neoprene collar noted around plumbing vent pipe

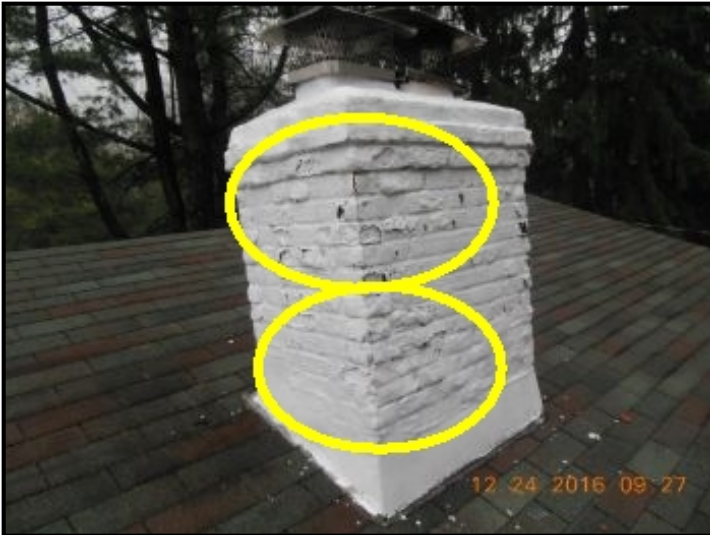
- **Repairs Needed. Both chimneys have been painted completely on the exterior sides. Painting masonry materials is not recommended as it prevents bricks from drying out leading to damage to bricks. Several cracked, damaged and spalled bricks were noted on chimney. Client should be aware that once the outside surface of brick is gone, the brick will erode away at an accelerated rate leading to water leakage into chimney and home. Due to conditions observed on fireplace chimneys, rebuilding of chimney may be necessary for proper repair. Recommend contacting a qualified chimney contractor to repair damaged chimneys as necessary prior to close to prevent further damage to chimney and water leakage into home.**

Spalling damage noted to mainy bricks on fireplace chimney

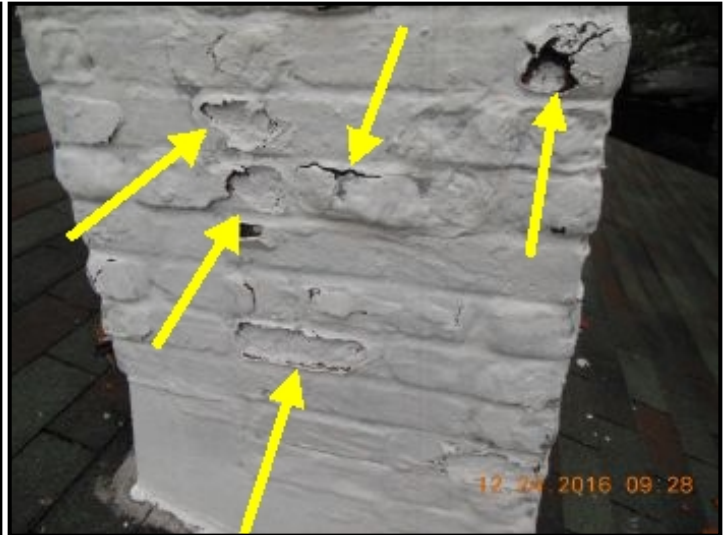
Closer look at brick damage on fireplace chimney

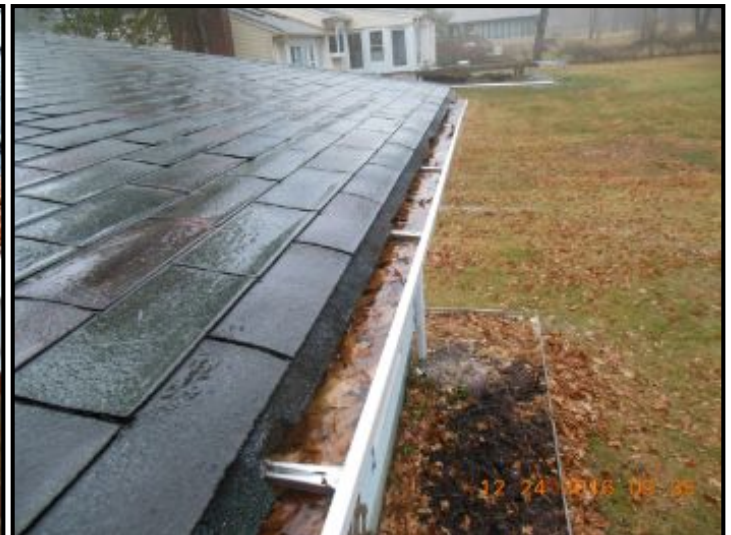
Gutters are full of leaves and overflowing

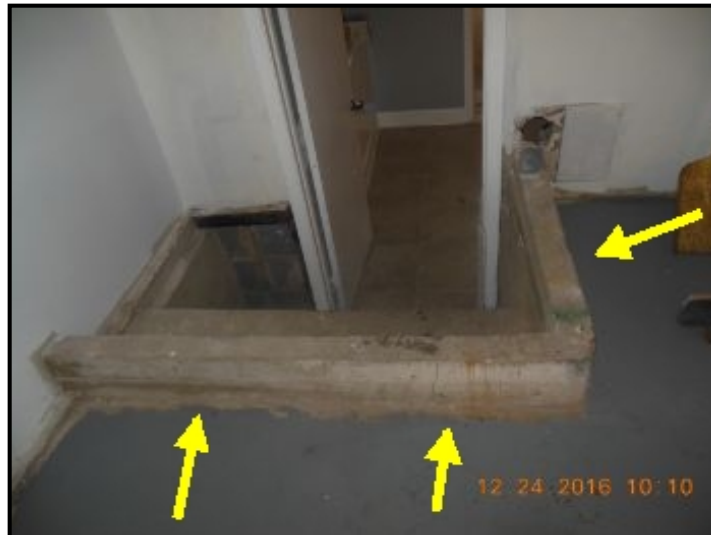
• **Hazardous. Bricks have been installed on the garage floor around the perimeter of the stairwell. It appears bricks have been installed as either a way to prevent water from draining down stairs or as a method to prevent people from falling into stairwell. However, this brick installation creates significant tripping hazard. Removal of bricks is recommended for safety. Recommend contacting a qualified building or handyman contractor to remove layer of bricks around perimeter of stairwell as necessary prior to close for safety.**

Bricks are installed around perimeter of stairwell in garage

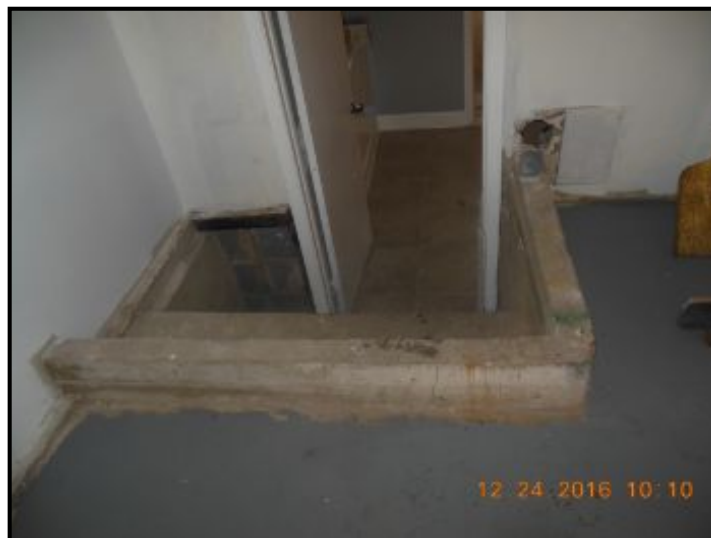
**• Hazardous. The handrail at stairwell in garage is missing. This conditions are possible tripping safety concerns. Recommend contacting a qualified building or railing contractor to install handrail as necessary prior to close for safety.**

Missing handrail at stairwell in garage

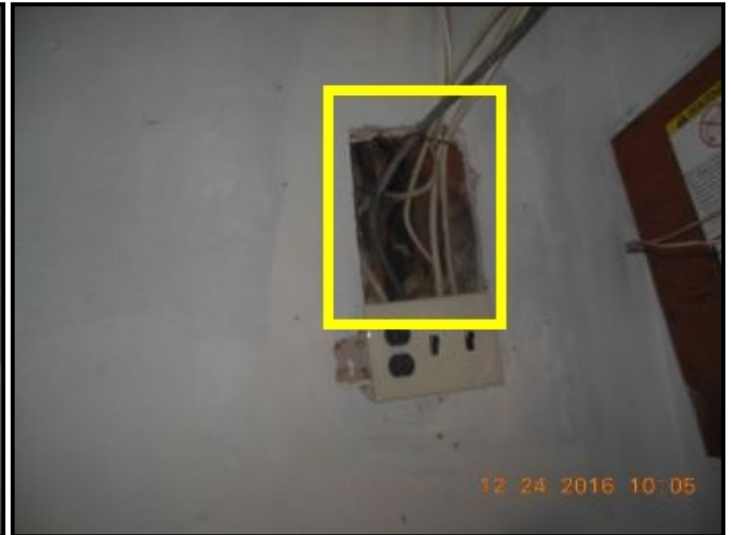
Open hole noted on firewall in garage

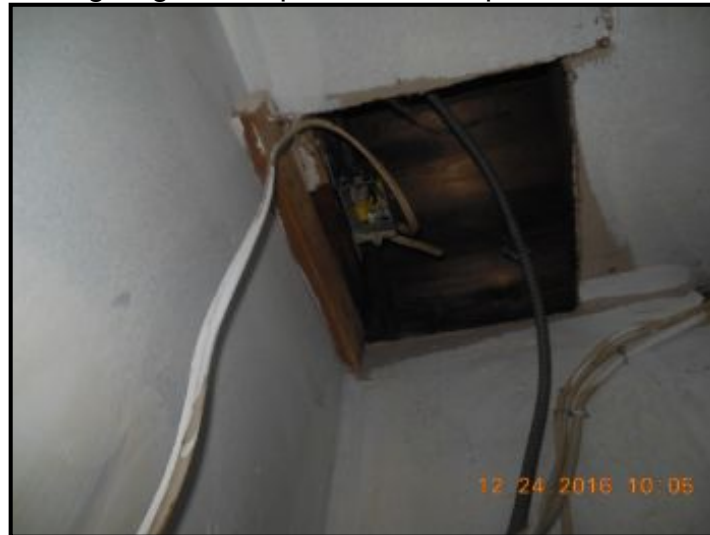
Open hole noted in garage firewall ceiling

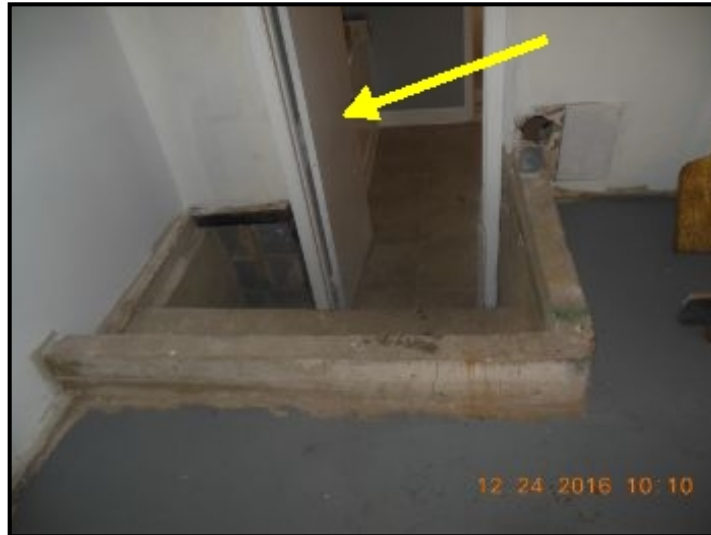
**• Recommendations. The fire door is not equipped with auto-closure hinges to close door automatically when released. Though not required, client should consider installing a device to close door automatically for safety enhancement. If client is concerned, it is recommended to contact a qualified building contractor to install self-closer device as necessary prior to close for safety enhancement.**

Fire door does not close automatically when released

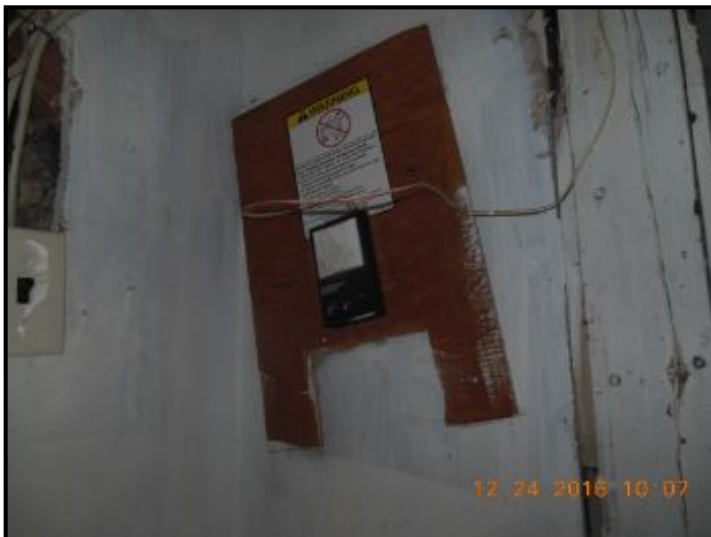
- **Repairs Needed. The push button for the door opener is hanging loosely on the wall. This condition can easily cause push button to fall from wall leading to damage to push button. Recommend contacting a qualified handyman to secure push button to wall as necessary prior to close to prevent damage to door opener push button.**

Plywood behind garage vehicle door push button is loose on wall

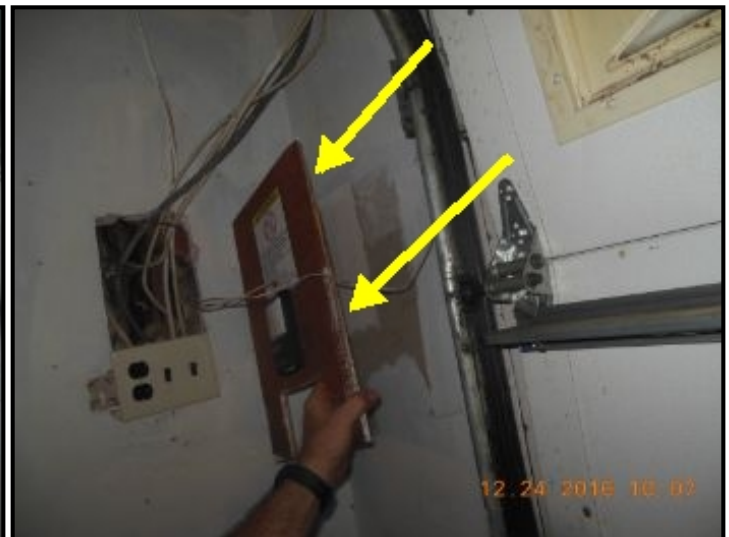
Plywood behind garage vehicle door push button is loose on wall

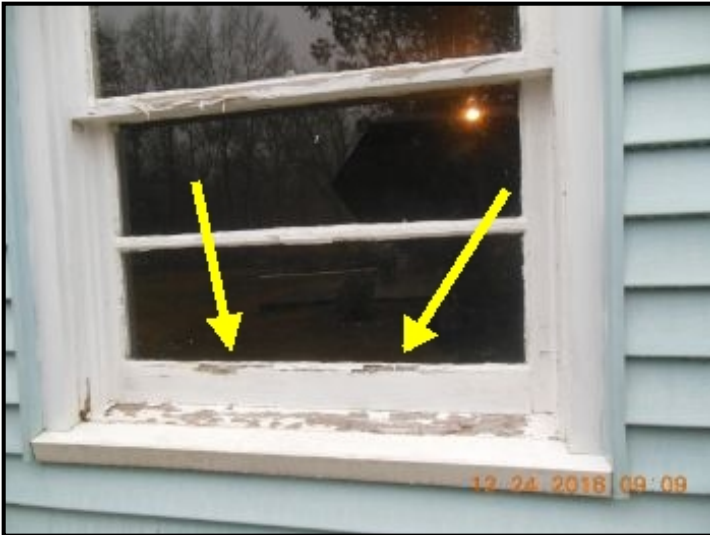
- **Repairs Needed. Peeling paint with missing window glass putty was noted on window in garage. Repairs are necessary to prevent further damage to window. Recommend contacting a qualified window or building contractor for repairs to window as necessary prior to close to prevent further damage to window.**

Peeling paint and missing putty noted on window glass

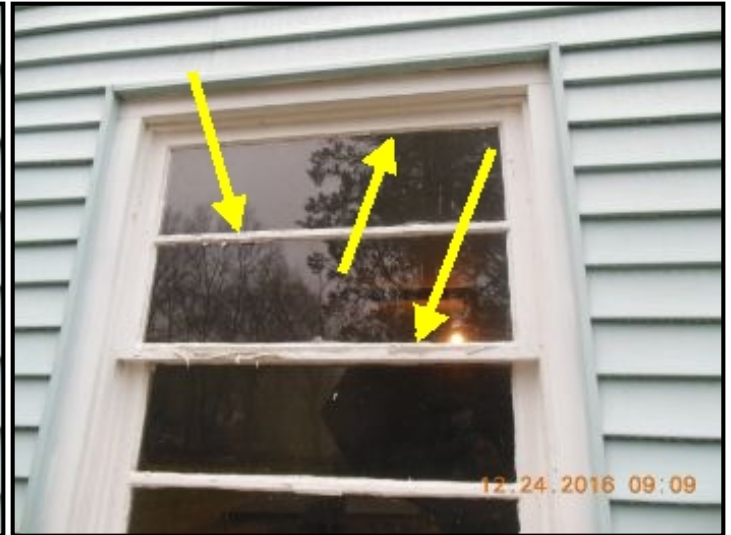
Peeling paint and missing putty noted on window glass

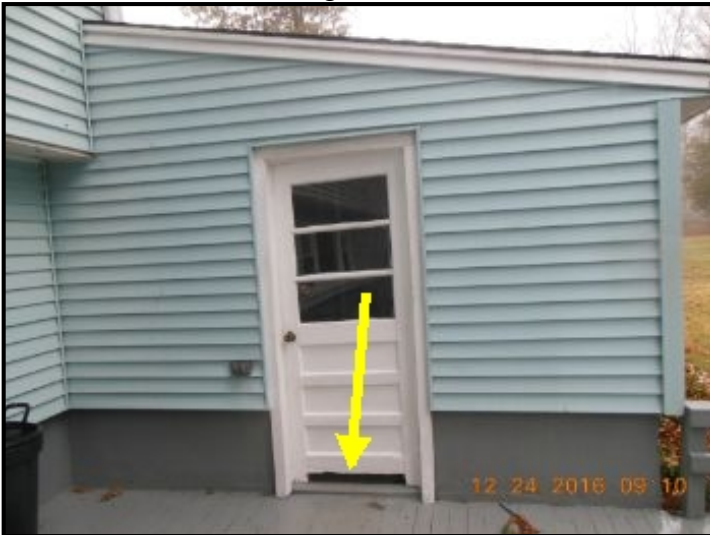
Bottom of service door is missing

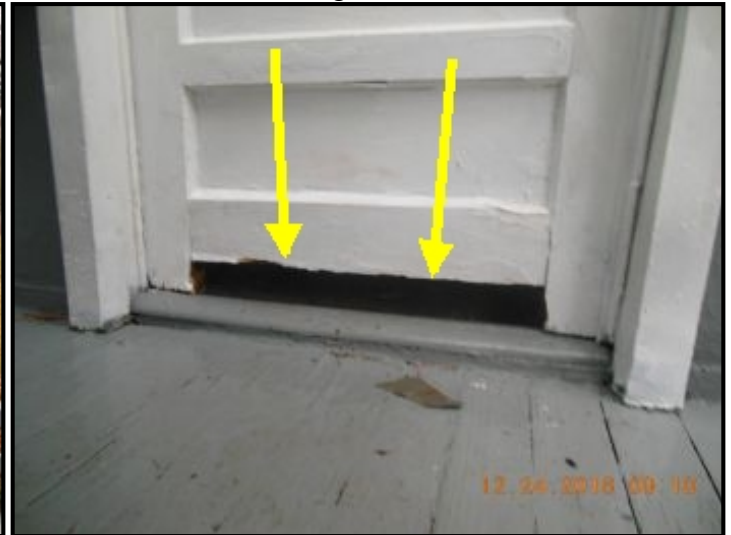
Closer look at damage to bottom of service door

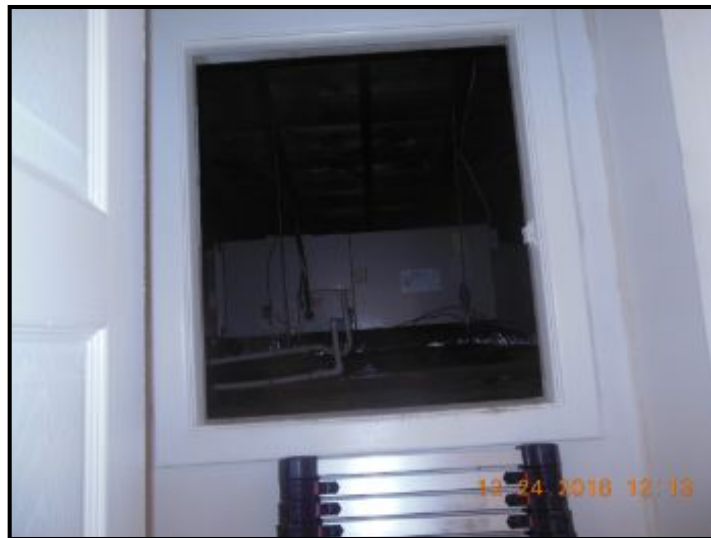
- **Defective. The attic access door to attic space is missing leaving wide open gap. This condition will allow air from home to enter attic space that could lead to ice damming conditions in winter and mold conditions on roof sheathing. Recommend contacting a qualified handyman contractor to install attic access door as necessary prior to close to prevent ice damming and mold conditions in attic space.**

Missing door noted at attic access opening

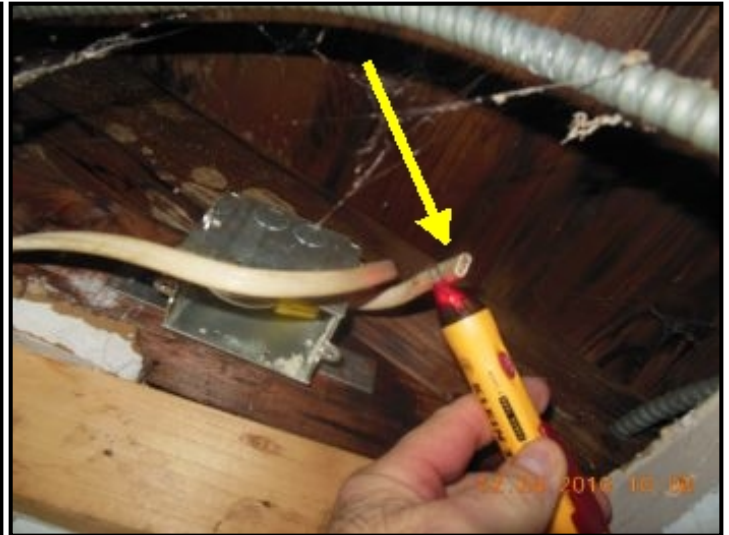
Cut live wire noted hanging above garage ceiling from open junction box

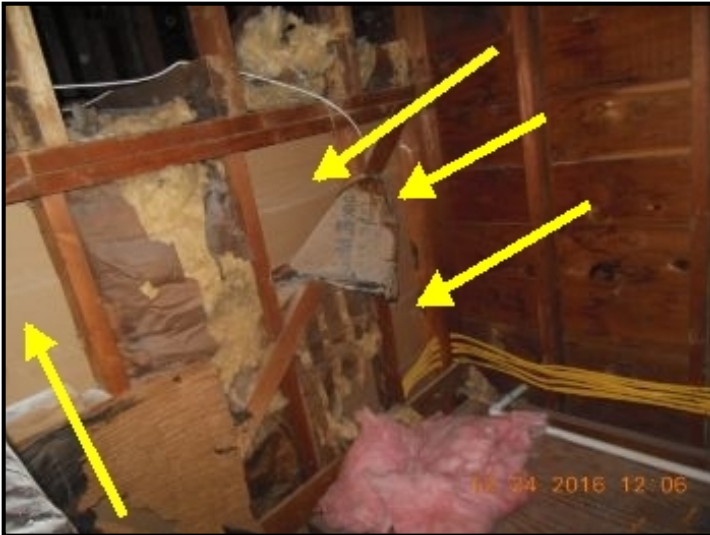
**• Repairs Needed. The thickness of insulation in some areas of attic are between about 2" to 4" of thickness typical of a home of this age resulting in poor insulating capacity. In addition, some areas of missing insulation was noted on vertical walls. Inspection was limited to one small area behind front knee wall in bedroom area. Client should be aware that the same insulation installations should be expected at other knee walls in third floor bedroom. Expect higher energy loss and heating & cooling energy expense. Installing additional insulation is recommended for improved insulating of home and heating/cooling energy efficiency. Though not required for resale of home, it is recommended to contact a qualified insulation contractor to install insulation where missing and upgrade the thickness of insulation as needed for improved insulating of home and fuel energy savings.**

Missing insulation noted on vertical walls in attic

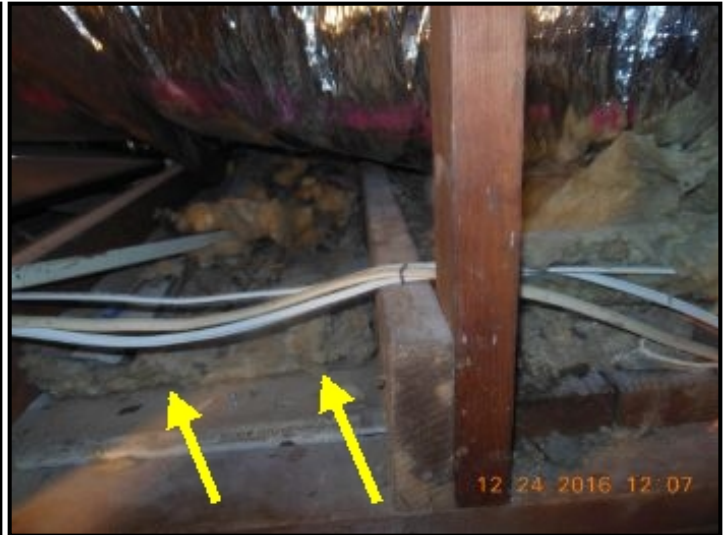
Old insulation in attic is batted down and thin

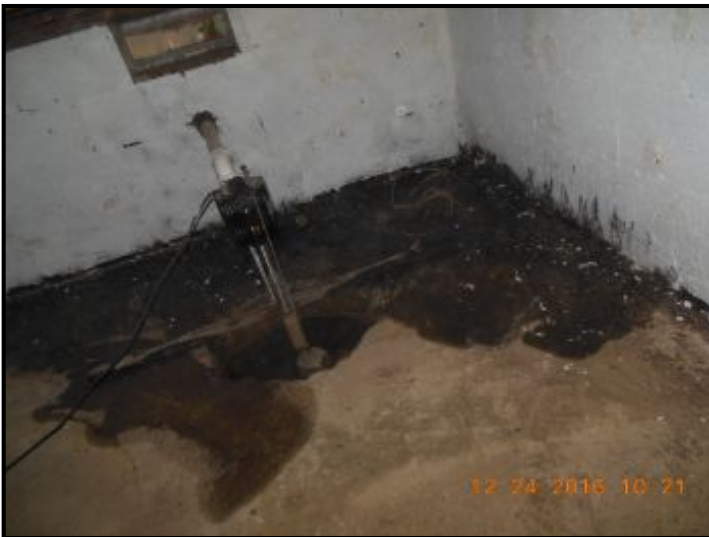
- **Defective. Wet seepage conditions were observed on floor of crawlspace at several different locations. Two sump pits and pumps are installed in this crawlspace but this condition indicates the water drainage system is not adequate to control the water seepage up from floor. It is recommended to contact a qualified water drainage system contractor to review crawlspace water drainage system for improvements or upgrade to water drainage system as necessary prior to close to prevent further water leakage into crawlspace.**

Wet floor noted in crawlspace indicating water drainage system is inadequate for water control

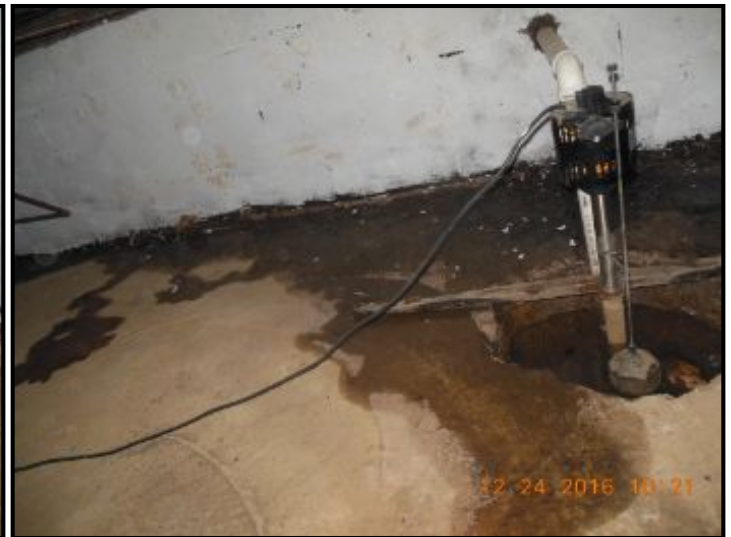
Wet floor around sump pit indicates water drainage system is inadequate

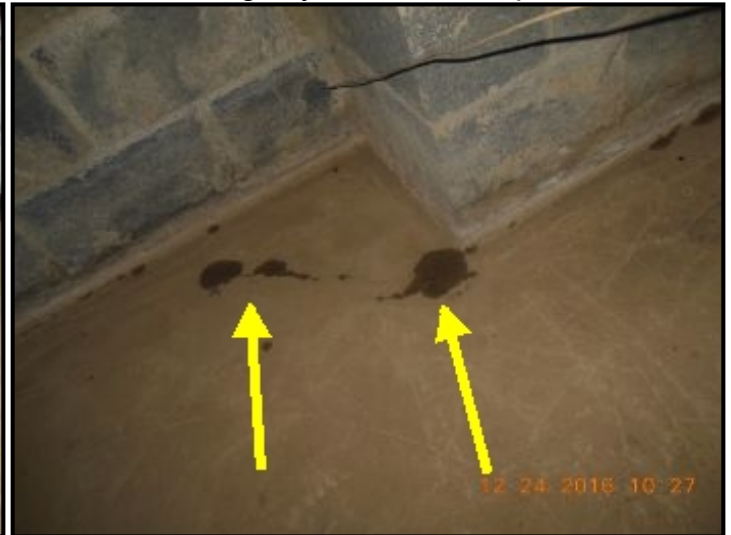
Wet spots on floor next to fireplace indicates water control in crawlspace is inadequate

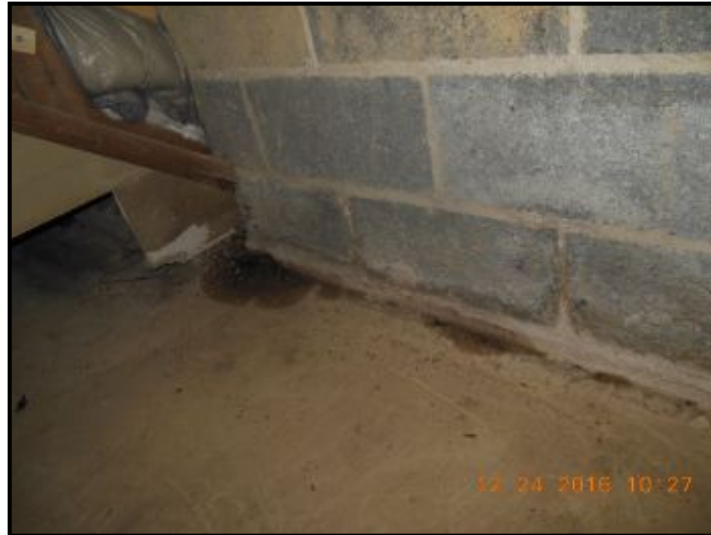
Moisture seepage up from floor noted near stairs in crawlspace

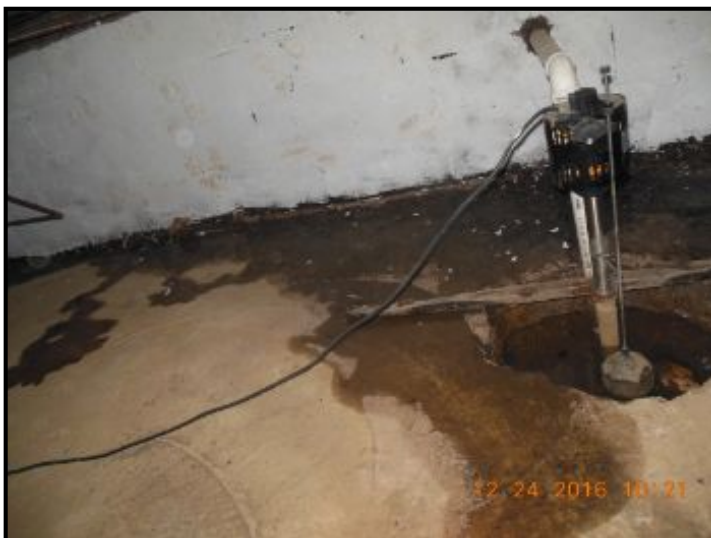
- **Defective.** The concrete floor in crawlspace was opened up and sump pumps installed in holes under floor. Client should be aware that this installation is not a professional drainage system and crawlspace most likely have problems with water seepage during heavy rainy conditions. Active wet floor at several different locations was observed in this crawlspace indicating this system is inadequate. t is recommended to contact a qualified water proofing specialist to review basement for installation of a professional water drainage system prior to close for adequate water control in crawlspace.

Wet floor in crawlspace indicates sump pits and pumps is inadequate in crawlspace

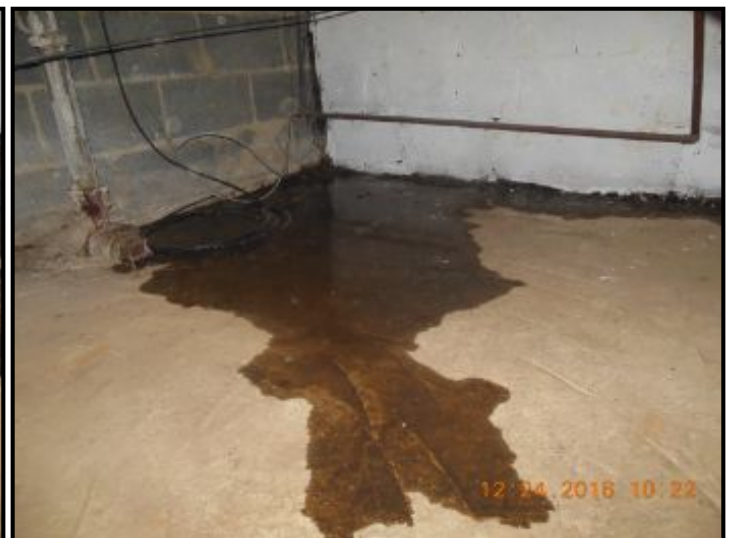
Wet floor in crawlspace indicates sump pits and pumps is inadequate in crawlspace

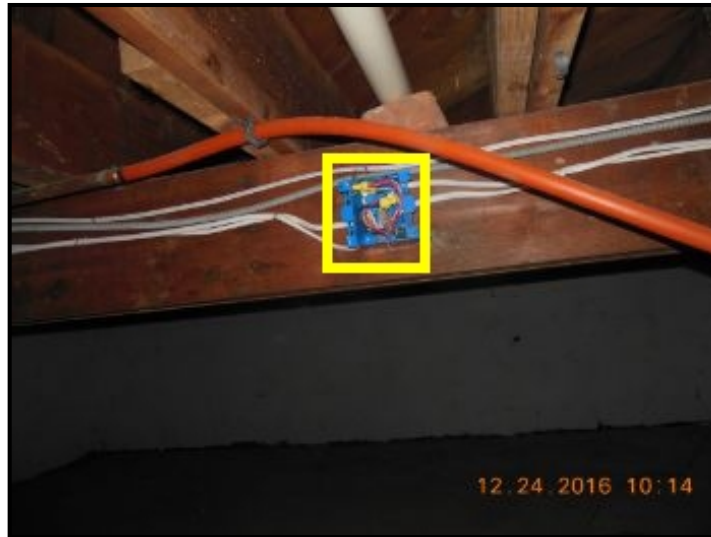
- **Hazardous. Open junction box with exposed wire splices was noted in basement. This condition is electrical short circuit and fire safety concern. All junction boxes must be covered for safety. Recommend repairs as necessary by qualified electrician prior to close for safety.**

Open junction box noted in crawlspace

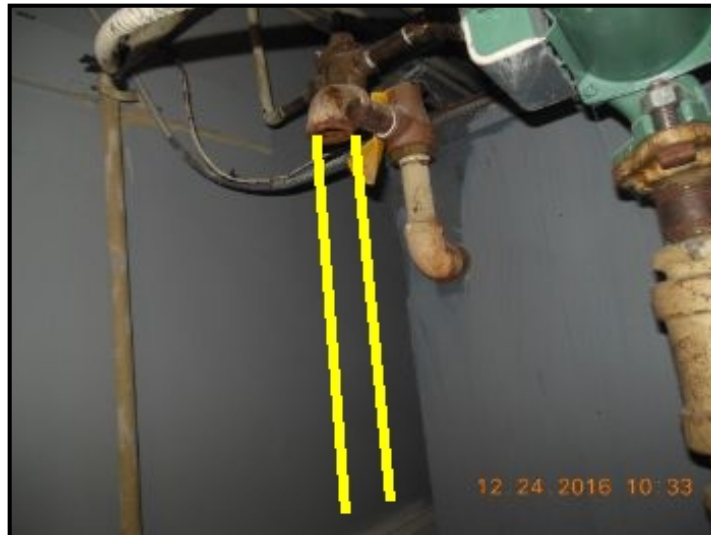
- **Hazardous. Missing Temperature Pressure Relief (TPR) valve extension pipe was noted on this boiler as required for safety. This safety valve releases water (and thus relieves pressure) if either the temperature or pressure in the tank gets too high. The TPR valve extension pipe must terminate from 2 to 6" above the floor for safety. Recommend having qualified plumber install extension pipe to terminate from 2" to 6" of floor prior to close for safety.**

Missing TPR extension pipe noted on boiler

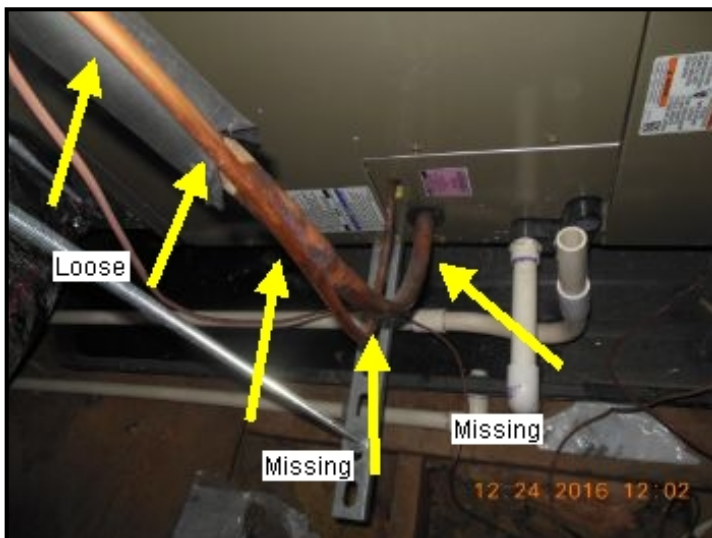
• **Repairs Needed. The insulation on the refrigerant lines at the air handler area is deteriorated or missing leaving refrigerant line bare. This condition will cause the refrigerant line to sweat and drip onto floor under air handler leading to moisture damage to floor. Recommend having insulation installed properly on refrigerant line as necessary prior to close to prevent moisture damage to floor under air handler.**

Loose and missing insulation noted on refrigerant line in attic

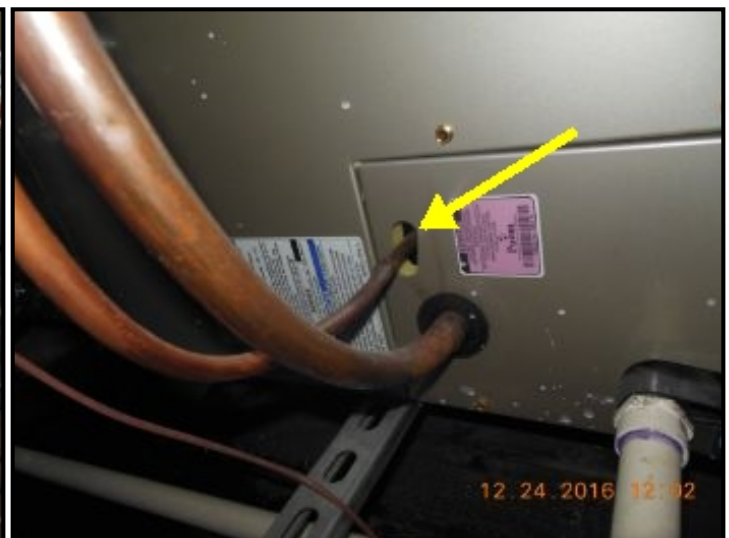
Wide open hole noted at evaporator coil area

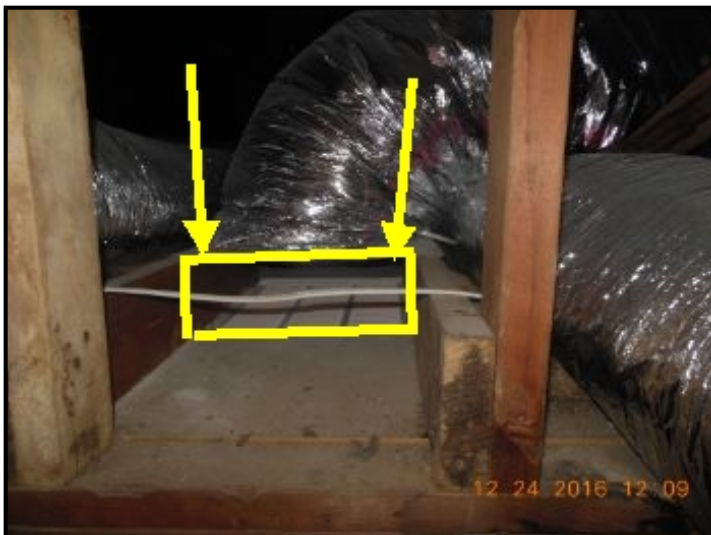
• **Defective.** Improper installation of return air duct register. Two large holes are present below flange of return air duct and ceiling register grill. These wide open holes will allow the hot attic air to be sucked into the return duct of air conditioner greatly affect the cooling of home and air circulation throughout home. In addition, during the heating season, the heating air in home will vent into attic space making heating of home very inefficient and wasteful. Both open holes will need to be blocked off to isolate return air flow into air handler. Recommend contacting a qualified HVAC contractor for repairs as necessary prior to close for adequate air flow and efficient cooling of home.

Wide open gaps noted at return duct flange and ceiling register
