# *Solid Foundation Home Inspections of NJ, LLC*

## Property Inspection Report

2305 Tall Street, Anytown, NJ 12345  
Inspection prepared for: Johnny Homebuer & Wendy Homebuyer  
Real Estate Agent: Jane Realtor - Best Realty Company - Basking Ridge

Date of Inspection: 12/24/2016  
Inspection# 21612-5555

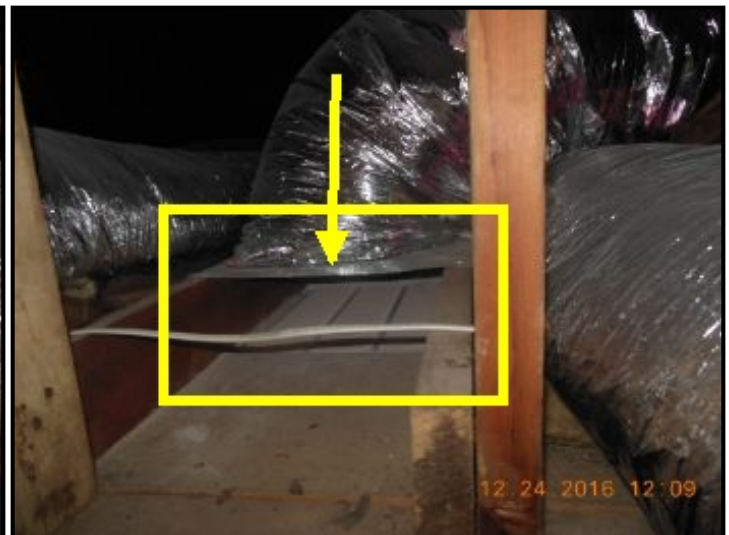
• **Defective.** Improper installation of return air duct register. Two large holes are present below flange of return air duct and ceiling register grill. These wide open holes will allow the hot attic air to be sucked into the return duct of air conditioner greatly affect the cooling of home and air circulation throughout home. In addition, during the heating season, the heating air in home will vent into attic space making heating of home very inefficient and wasteful. Both open holes will need to be blocked off to isolate return air flow into air handler. Recommend contacting a qualified HVAC contractor for repairs as necessary prior to close for adequate air flow and efficient cooling of home.

Another angle showing wide open holes between return duct flange and ceiling

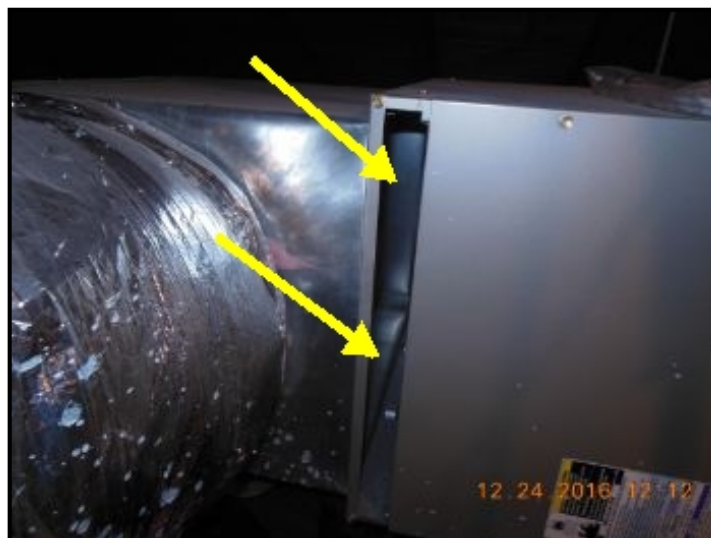
• **Defective. Missing filter was noted in forced air system located in attic for second floor air conditioning system. A filter is necessary to keep evaporator coil of air conditioning system clean of dust debris. A missing filter will lead to clogged evaporator coil and restriction of air flow through coil. It will also lead to mold growth on evaporator coil and unhealthy air circulation throughout home. Inspector is not able to determine how long filter was missing and also not able to inspect evaporator coil for condition due to inaccessibility. Recommend contacting a qualified HVAC contractor to review condition of evaporator coil for cleaning as necessary for healthy air circulation throughout home. It is also recommended to have filter installed by qualified HVAC contractor to keep forced air system clean and healthy air circulation throughout home.**

Missing filter noted at air handler in attic

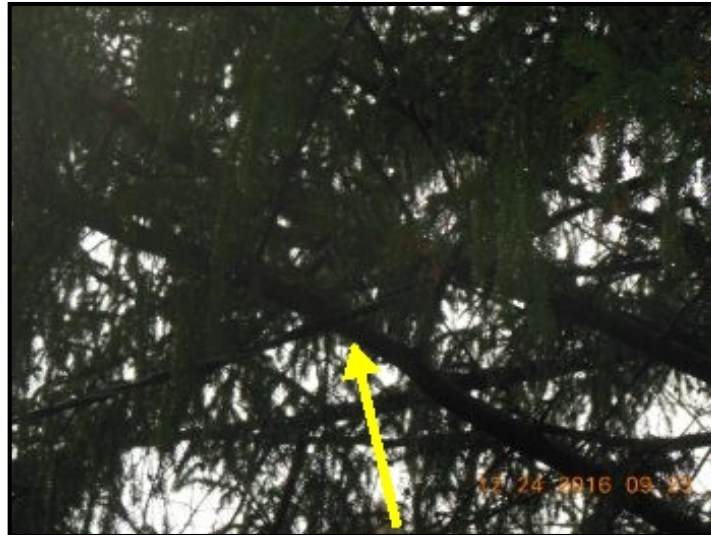
• **Repairs Needed.** The main service lines from telephone pole to home are rubbing the tree branches. This condition will cause damage to overhead service lines leading to electrical disruption to home. Recommend contacting the local electric utility company to review main service lines for damage and replacement, if necessary, and cover main service lines with plastic cover where wires are rubbing the tree trunk as necessary prior to close to prevent damage to service lines and electrical disruption to home.

Main service lines are rubbing the tree branches

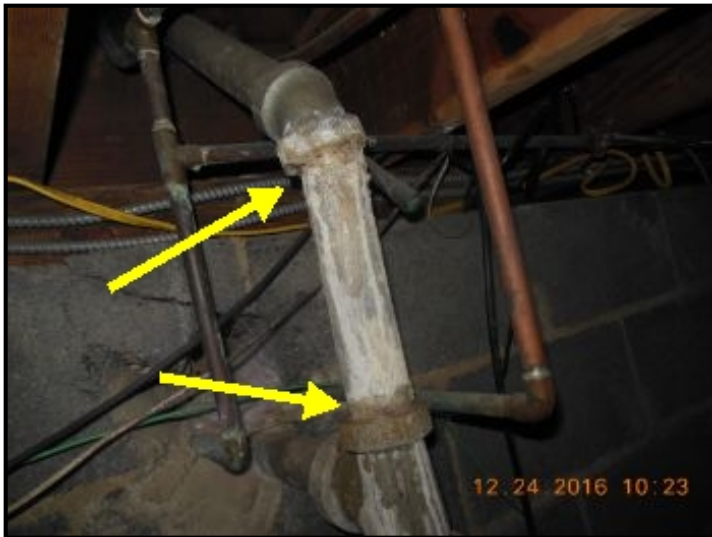
Corroded patched and leaking waste drain pipe in crawlspace

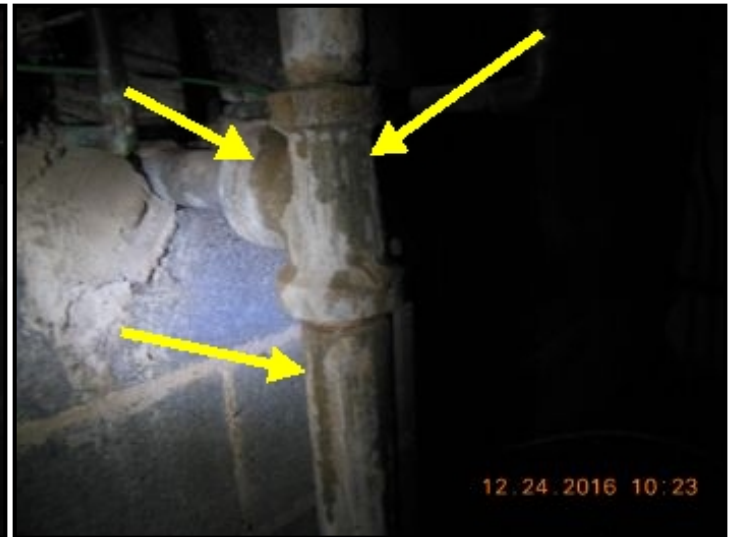
Wet stains on pipes indicate active leakage

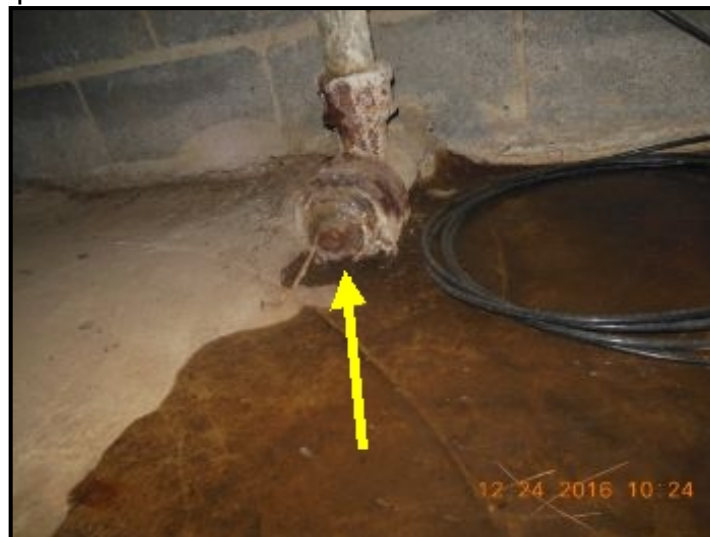
- **Recommendations. Galvanized drain lines are installed for some of the drain lines for waste drainage. For your information, galvanized lines clog over time on the inside from impurities in the water attaching to the walls of the lines. If drain lines show restriction by slow or no drainage, replacement of lines will most likely be needed. No evidence of restriction was noted during the home inspection. If concerned, it is recommended to contact a qualified plumber for review conditions of galvanized drain lines for his/her recommendations prior to close.**

Corroded and leaking galvanized drain line at clean out cap

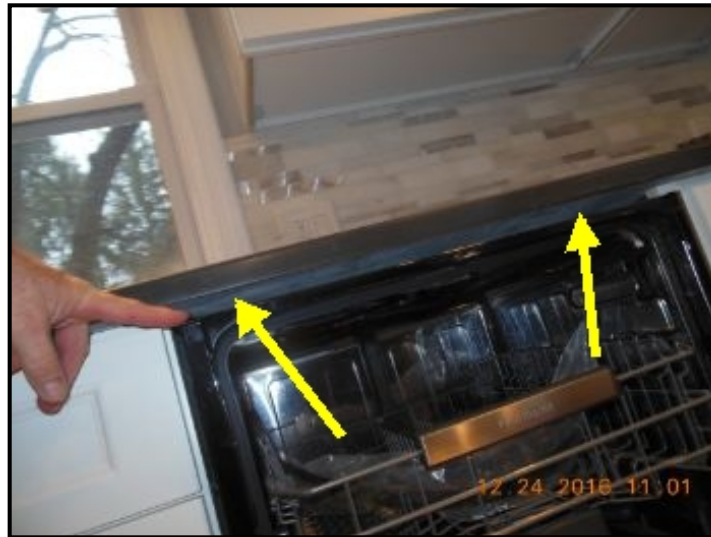
• **Repairs Needed. Dishwasher installation is loose and not secured in place. This loose installation could damage dishwasher and/or plumbing lines. Recommend contacting a qualified handyman or building contractor to secure dishwasher to cabinet as necessary prior to close to prevent damage to dishwasher or plumbing pipes.**

Dishwasher is not secured in place

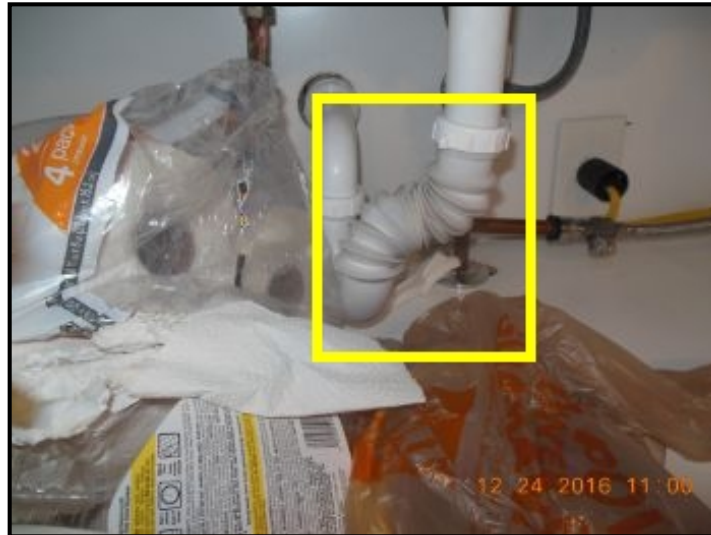
• **Repairs Needed. Non-approved ribbed drain pipe is installed under the kitchen sink indicating non-professional repairs. This type of drain pipe can cause chronic drainage problems and bad odors from debris build-up. All drain pipes must be smooth surfaced for reliable and odor free drainage. Recommend replacement of ribbed section of drain pipe as necessary by qualified plumber prior to close for reliable odor free drainage of sink.**

Improper ribbed drain pipe is installed under kitchen sink

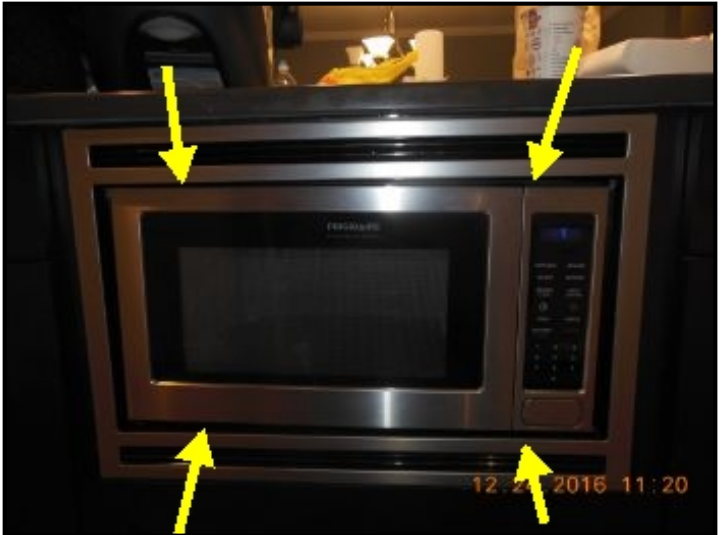
• **Repairs Needed. Loose cabinet trim piece was observed around the microwave oven. With trim piece installed, the microwave oven door hits the trim piece that will cause trim piece to move eventually leading to damage to trim piece and/or microwave oven door. Adjustment of shelf tracks, microwave oven and/or trim piece is necessary for proper repair. Recommend contacting a qualified appliance and/or cabinet contractor for repairs as necessary prior to close to prevent damage to microwave oven door and/or trim piece.**

Trim piece around microwave oven is not installed properly Cabinet trim piece is installed unevenly and loose around microwave oven

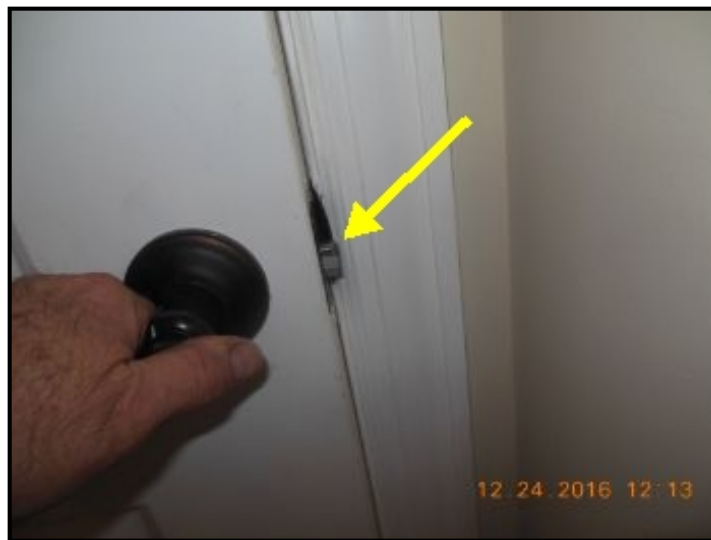
• **Repairs Needed. The bathroom entry door for upper level hallway bathroom does not latch shut. Simple adjustment of latch plate on door frame will correct this condition. Recommend contacting a qualified building contractor for repairs as necessary prior to close for privacy.**

Upper level bathroom entry door does not latch shut

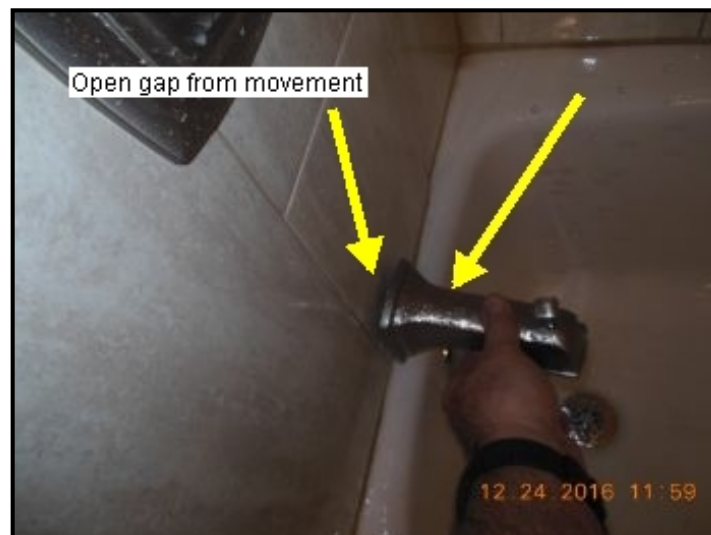
Tub faucet moves significantly in wall at upper level hallway bathroom

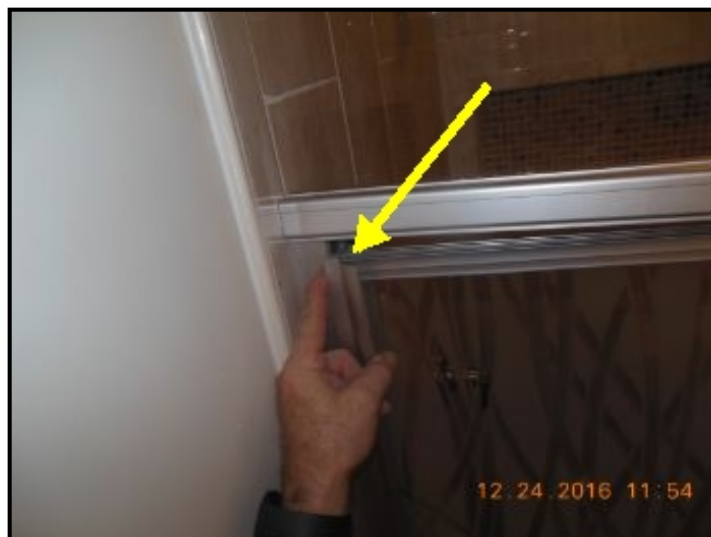
Shower door is improperly installed and loose at bedroom bathroom

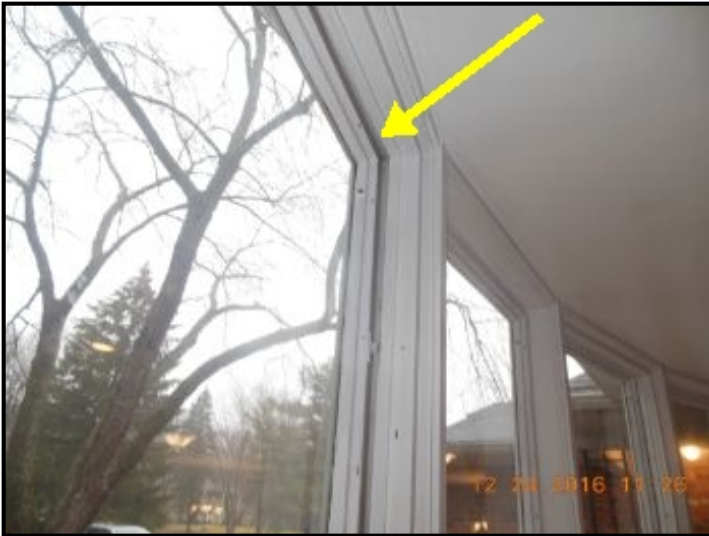
Casement window is stuck at top side

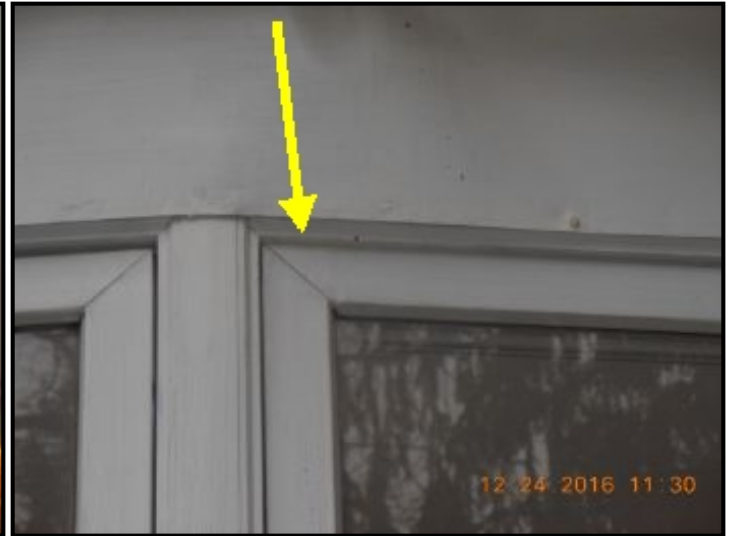
Casement window is stuck at top side

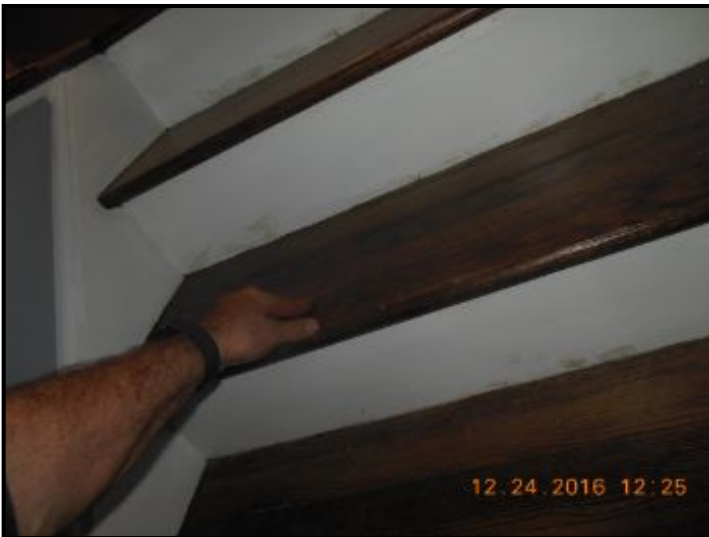
Several loose step planks noted at stairs

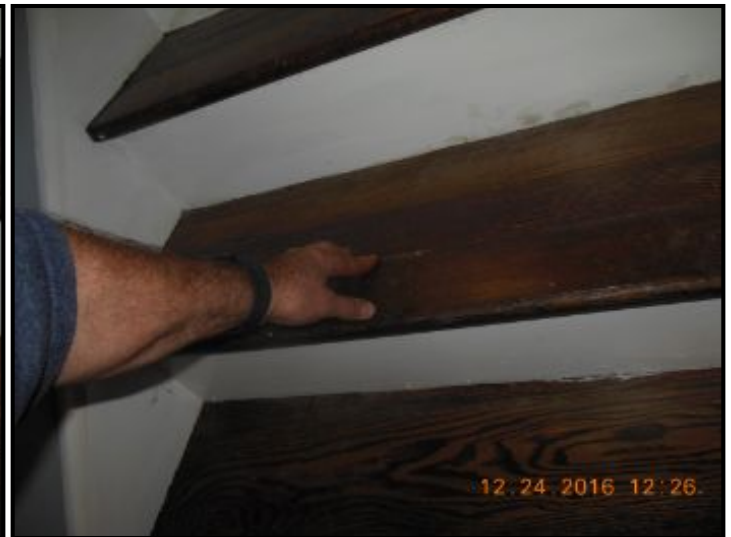
Several loose step planks noted at stairs

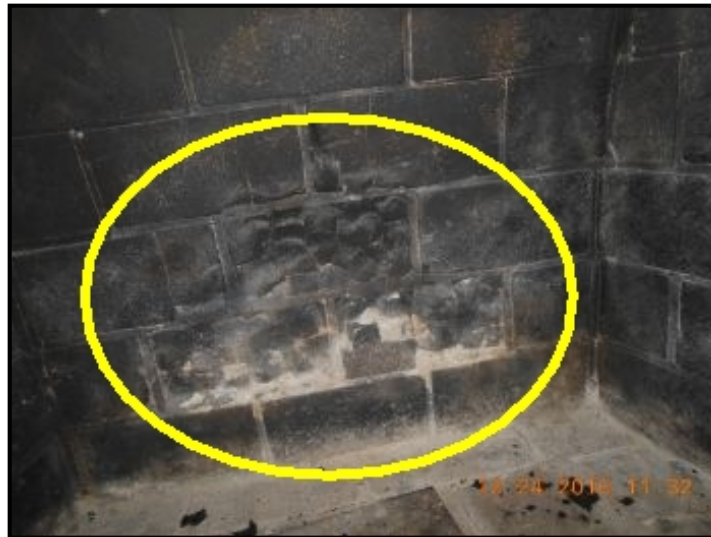
Back wall in fireplace is significantly damaged

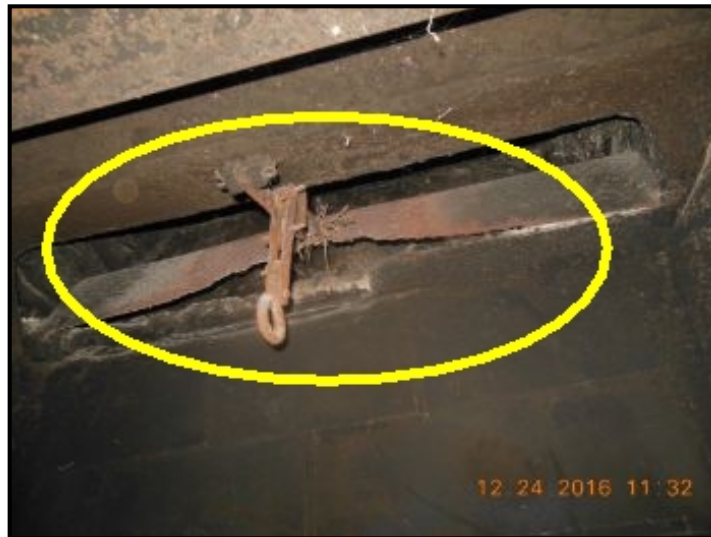
Damper is rusted out with wide open hole
