# *Solid Foundation Home Inspections of NJ, LLC*

## Property Inspection Report

2305 Tall Street, Anytown, NJ 12345  
Inspection prepared for: Johnny Homebuer & Wendy Homebuyer  
Real Estate Agent: Jane Realtor - Best Realty Company - Basking Ridge

Date of Inspection: 12/24/2016  
Inspection# 21612-5555

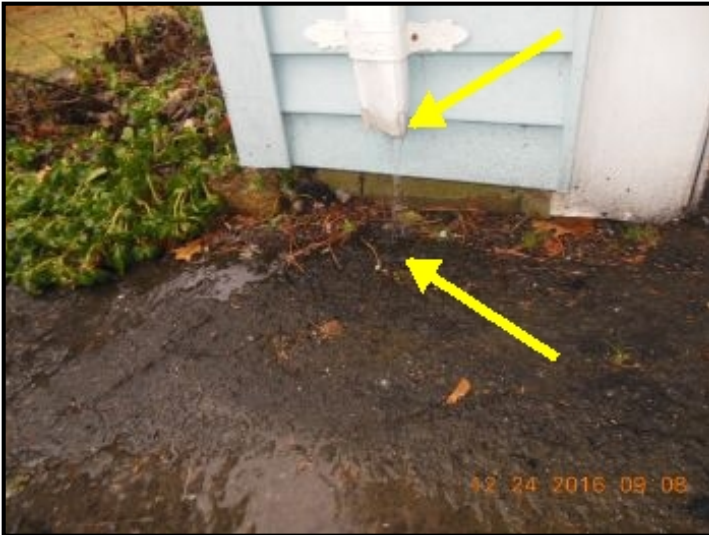
• **Repairs Needed.** Some or all of the downspouts drain close to or directly next to the homes and the garage foundation walls. If not corrected, this will allow water to drain towards foundation possibly causing consequential moisture damage. If basement is present, this will allow moisture to seep into basement walls. Suggest having qualified gutter contractor add extension pipes to downspouts where needed prior to close for proper roof water drainage away from homes and garage foundation walls.

Water is draining next to foundation blocks

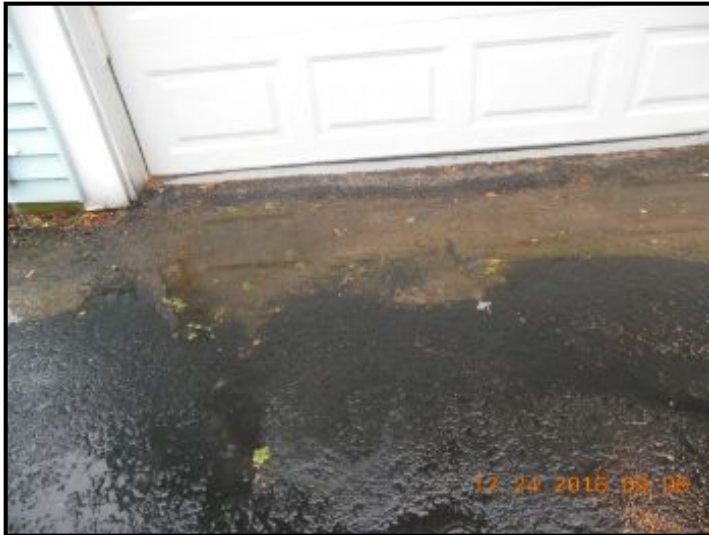
• **Repairs Needed. Two large puddles of water were observed at front of garage vehicle door. These two puddles will be slippery in winter freezing conditions. It appears water is draining towards the garage. An asphalt hump has been installed at front of garage floor to prevent water from draining into garage. This hump can make entry into the garage difficult and can prevent high vehicle (SUV, truck, etc.) from entering garage. A drain should be installed in front of garage to prevent water from collecting in front of garage. Recommend removal of the asphalt hump and have underground drain installed at front of garage by qualified asphalt driveway contractor as necessary prior to close for easy access into garage and to prevent water from draining into garage.**

Water collects in front of garage vehicle door with hump of asphalt installed to prevent water leakage into the garage

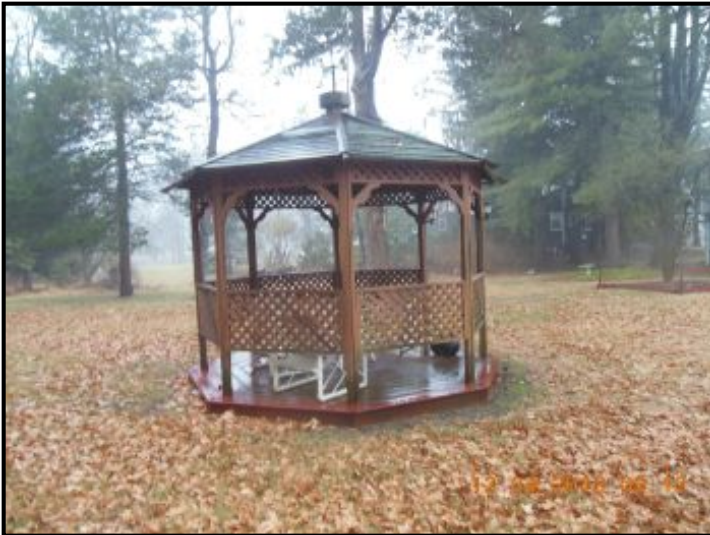
**• Recommendations. A detached gazebo is installed on the property of this home. Structure was reviewed and some minor rodent damage was observed inside gazebo under roof. This damage does not affect structure at this time. If client is concerned, recommend having gazebo reviewed by qualified building contractor for his/her recommendations prior to close.**

Detached gazebo in yard is in serviceable condition

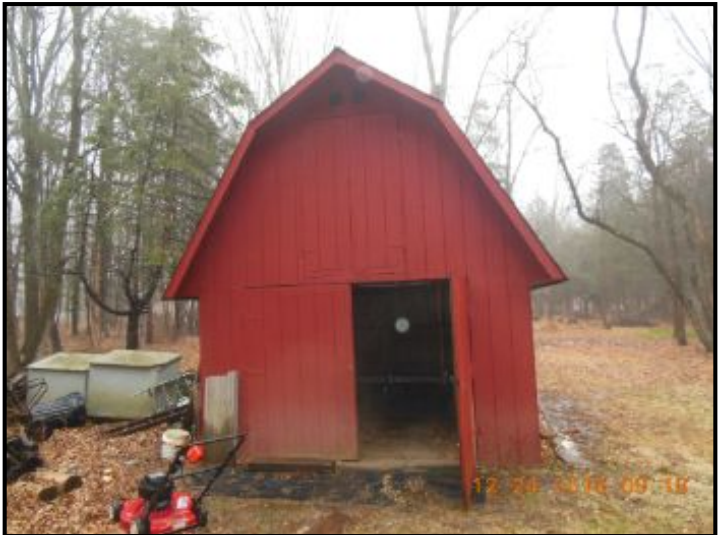
Shed installed in yard is in general good condition

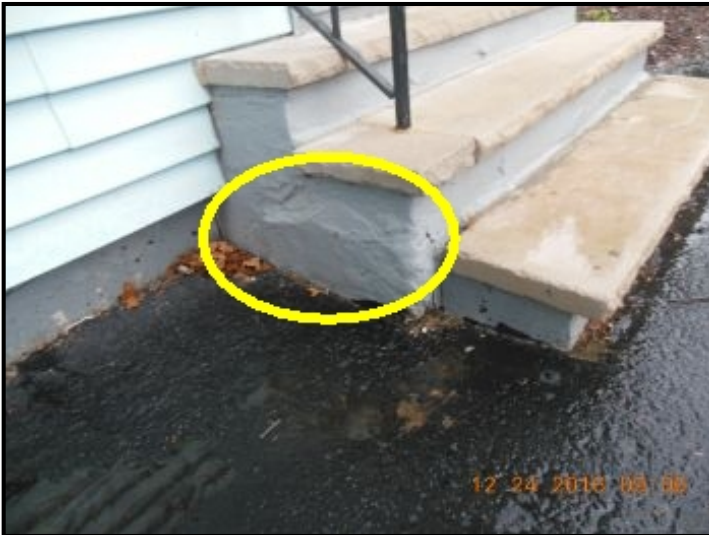
• **Repairs Needed.** The concrete stucco covering over the blocks on the side of the front and side porches are swollen, cracked, loose and/or missing. If not repaired, this condition will lead to damage to blocks on porch. Client should be aware that damage may be present to the cinderblocks behind the concrete stucco covering not visible until concrete stucco has been removed. Recommend having porch repaired as necessary by qualified mason prior to close to prevent further damage to porch.

Swollen concrete stucco indicating damage to blocks under stucco

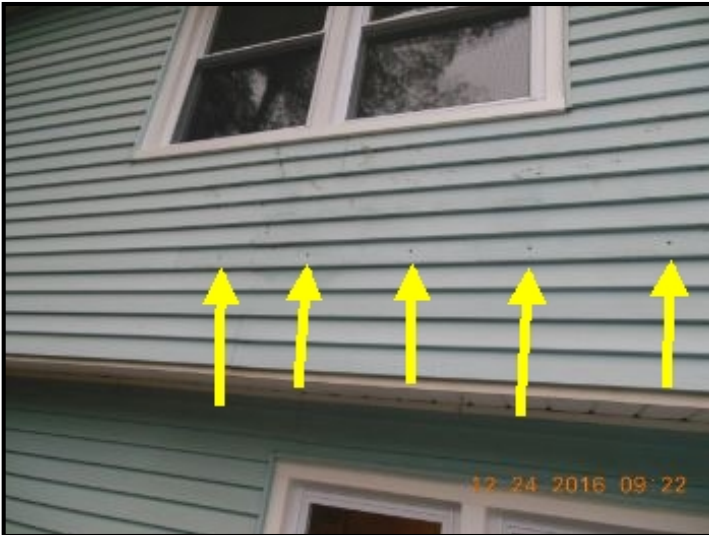
• **Repairs Needed. Several open holes in vinyl siding were observed at rear side of home most likely from removed deck cover. This condition will lead to water seepage and damage to sheathing behind siding. Recommend contacting a qualified siding contractor to repair or replace siding as necessary prior to close to prevent further damage to siding or home.**

Open holes were noted in vinyl siding from removed deck awning cover

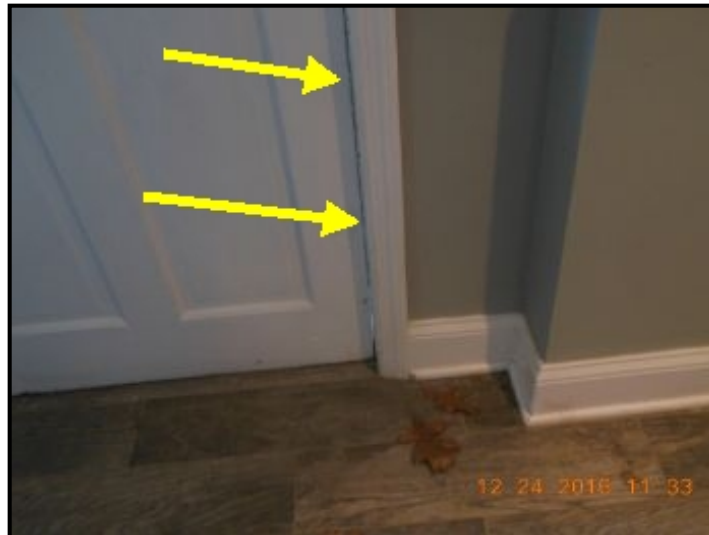
• **Repairs Needed. Wide open gap was noted at rear entry door in closed position. This open gap will create drafty conditions at door. Installing weather stripping at this area may help with stopping drafts through gap. Recommend contacting a qualified door or handyman contractor to install weather stripping around door as necessary prior to close to prevent drafty conditions through door and energy cost savings.**

Open gaps at side of rear entry door

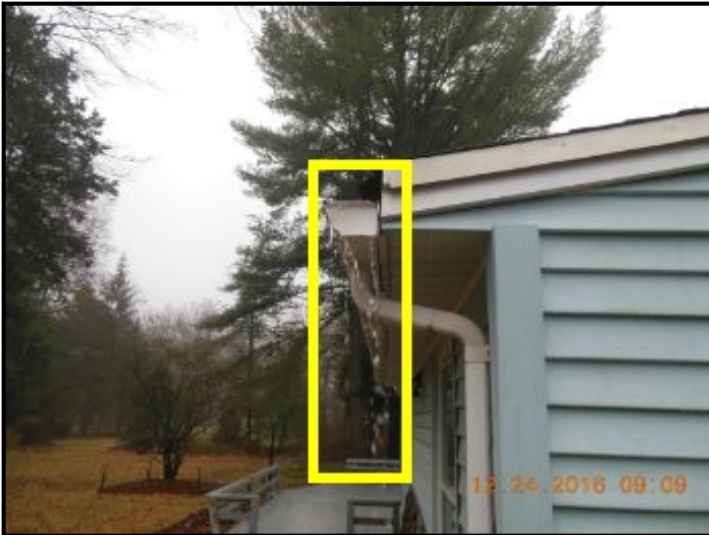
**• Repairs Needed. Gutters are filled with debris. This condition will allow gutters to overflow and cause water to drain next to the homes foundation. Recommend having gutters cleaned as necessary periodically by gutter cleaning contractor for proper roof water drainage away from homes foundation.**

Gutters are overflowing from heavy leaf buildup in gutters

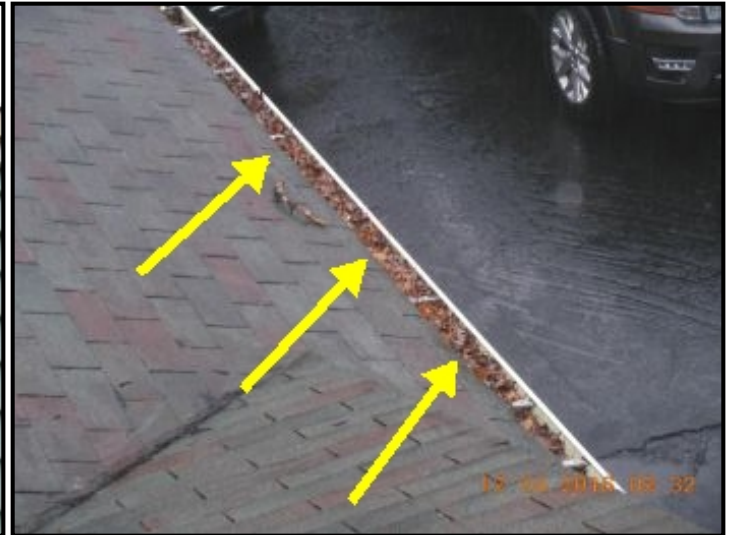
Gutters are full of leaves

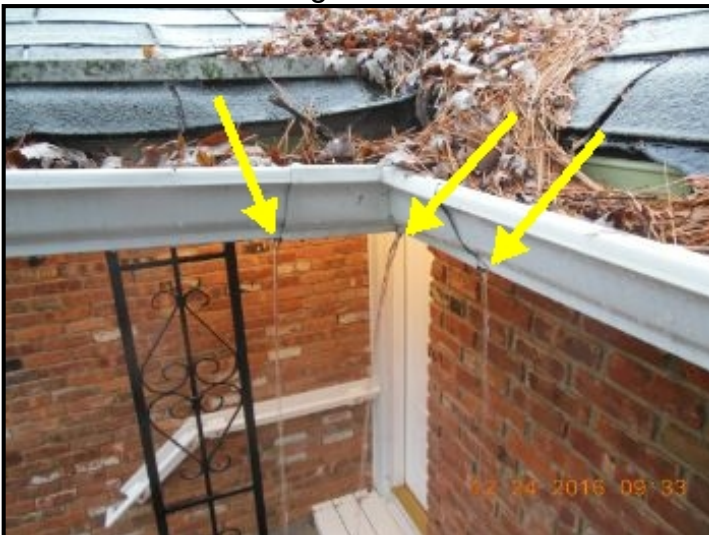
**• Defective. Leakage at seams of gutters were observed at several different locations around the home. This condition will cause water to drain next to the homes foundation. Recommend contacting a qualified gutter contractor to seal gutters where leaking prior to close for proper water drainage away from homes foundation walls.**

Gutters are leaking at seams

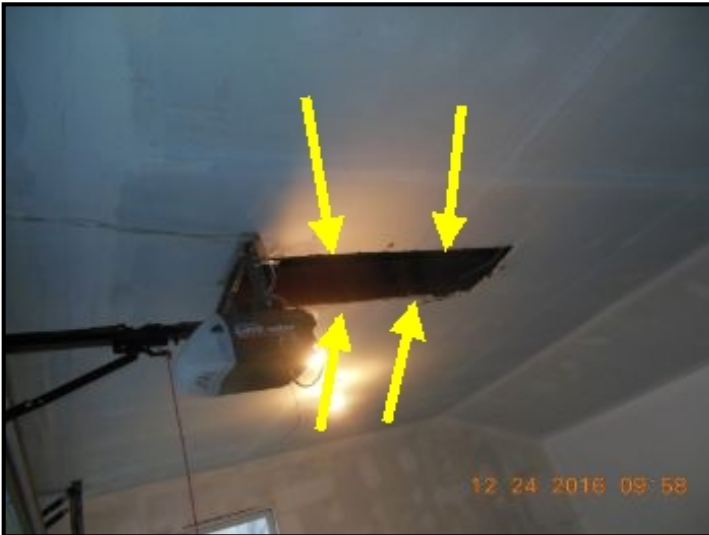
• **Hazardous. Wide opening was observed on the garage ceiling for access to attic. Since sheetrock is not installed at house framing in attic, this ceiling serves as a firewall. In addition, another wide open hole was observed on ceiling in garage. These open holes are fire safety concerns. Recommend installing sheetrock at access opening to attic space in garage and open hole in firewall ceiling by qualified building contractor prior to close for fire safety of home.**

Open hole noted at access to garage attic space

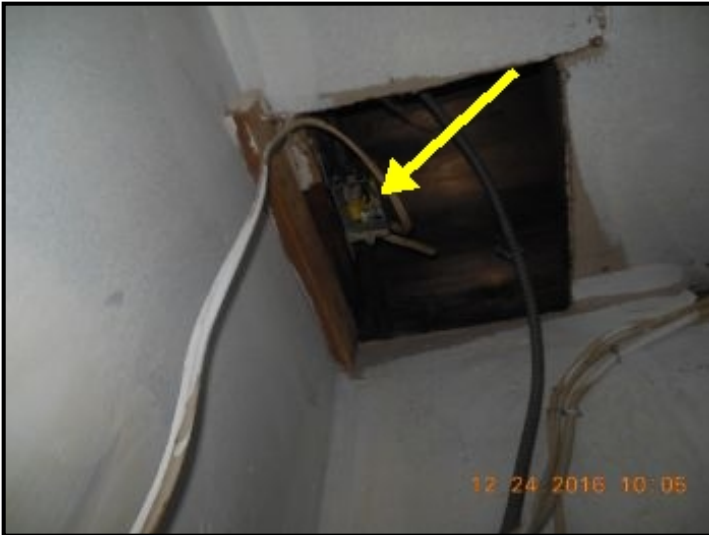
Page 36 Item: 5	Electrical	<ul style="list-style-type: none"> <li>• <b>Hazardous.</b> Open junction box were observed in garage attic space leaving "live" wire splices exposed. In addition, one wire coming from this box has been cut and wire is live. This condition is an electrical short circuit safety concern. Recommend contacting a qualified electrician for repairs as needed prior to close for safety.</li> </ul>
Page 37 Item: 7	Insulation Condition	<ul style="list-style-type: none"> <li>• <b>Repairs Needed.</b> The thickness of insulation in some areas of attic are between about 2" to 4" of thickness typical of a home of this age resulting in poor insulating capacity. In addition, some areas of missing insulation was noted on vertical walls. Inspection was limited to one small area behind front knee wall in bedroom area. Client should be aware that the same insulation installations should be expected at other knee walls in third floor bedroom. Expect higher energy loss and heating &amp; cooling energy expense. Installing additional insulation is recommended for improved insulating of home and heating/cooling energy efficiency. Though not required for resale of home, it is recommended to contact a qualified insulation contractor to install insulation where missing and upgrade the thickness of insulation as needed for improved insulating of home and fuel energy savings.</li> </ul>

- **Hazardous. Open junction box were observed in garage attic space leaving "live" wire splices exposed. In addition, one wire coming from this box has been cut and wire is live. This condition is an electrical short circuit safety concern. Recommend contacting a qualified electrician for repairs as needed prior to close for safety.**

Open junction box noted in garage attic space

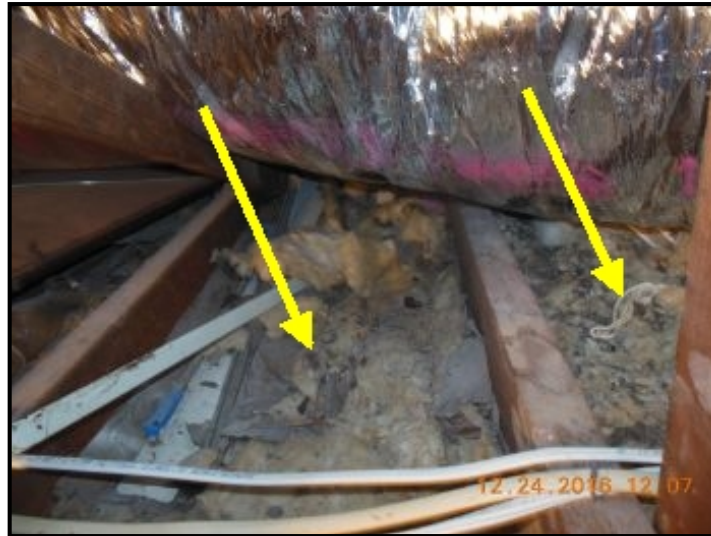
Old insulation in attic is batted down and thin

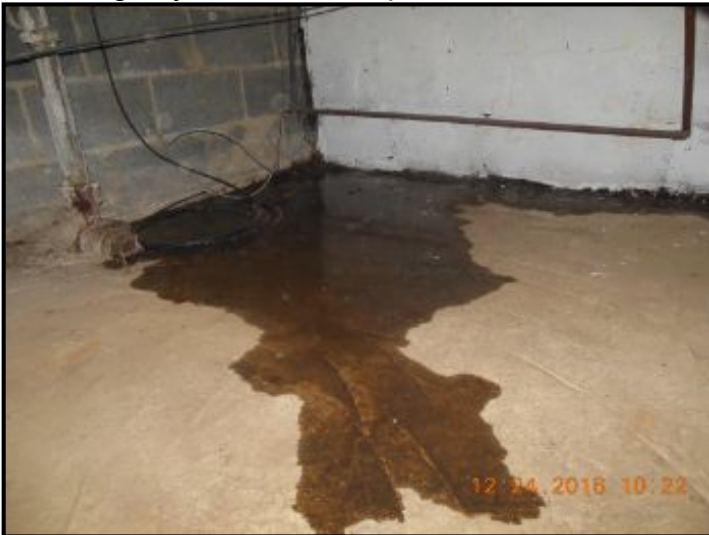
<b>Basement/Crawlspace</b>		
Page 40 Item: 13	Moisture Seepage Evidence	<ul style="list-style-type: none"> <li>• <b>Defective.</b> Wet seepage conditions were observed on floor of crawlspace at several different locations. Two sump pits and pumps are installed in this crawlspace but this condition indicates the water drainage system is not adequate to control the water seepage up from floor. It is recommended to contact a qualified water drainage system contractor to review crawlspace water drainage system for improvements or upgrade to water drainage system as necessary prior to close to prevent further water leakage into crawlspace.</li> </ul>

Wet floor around sump pit indicates water drainage system is inadequate

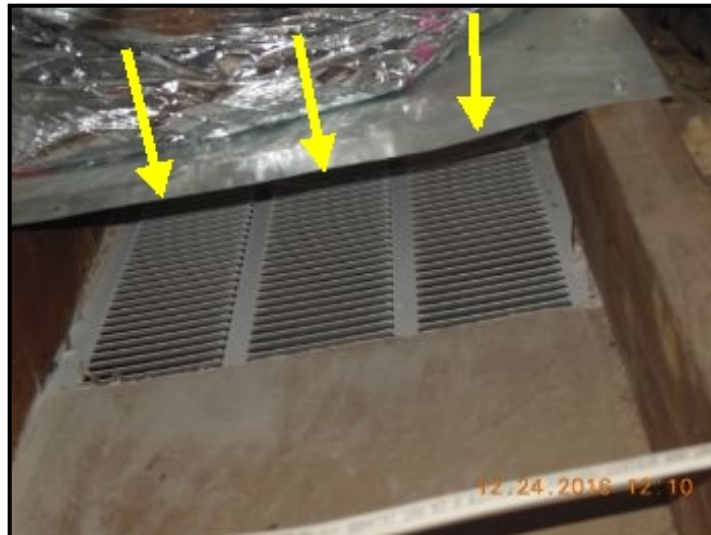
Another angle showing wide open holes between return duct flange and ceiling

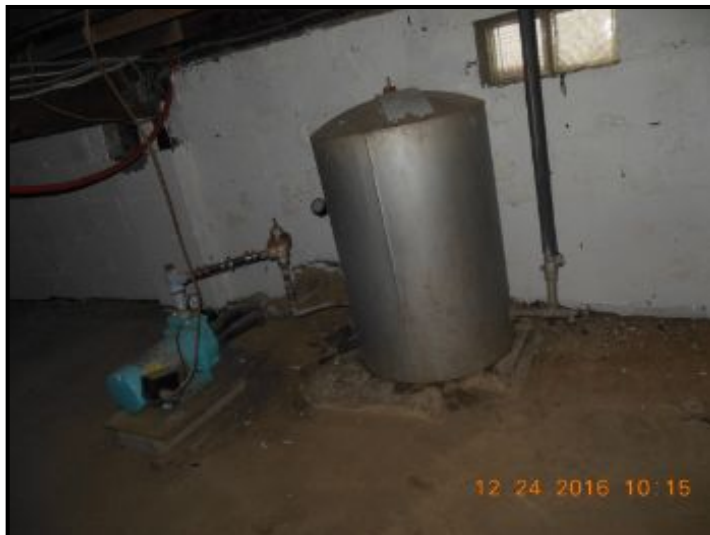
**• Recommendations. An above ground well pump is installed in this home. This type of pump indicates the well water is less than 35' deep. The well water of this depth is vulnerable to ground water bacteria contamination. Testing the water is not within the scope of this inspection. It is recommended to contact a qualified well water testing lab to sample the water for the presence of water contamination for health safety.**

An above ground well pump is installed in the crawlspace

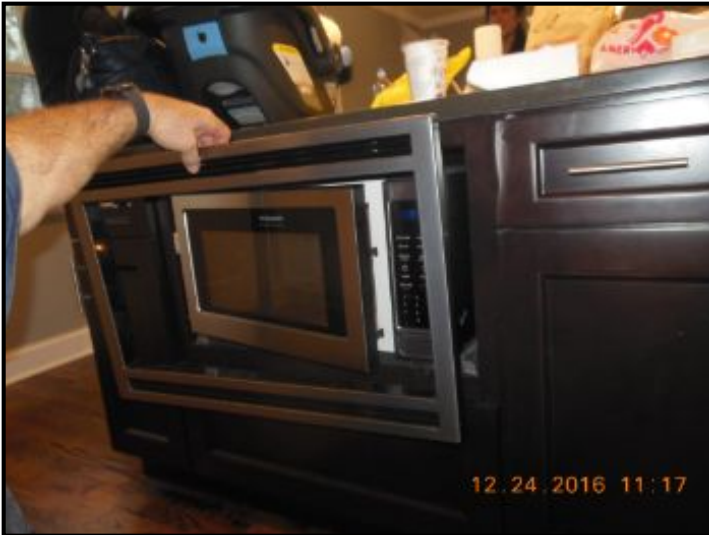
• **Repairs Needed. Loose cabinet trim piece was observed around the microwave oven. With trim piece installed, the microwave oven door hits the trim piece that will cause trim piece to move eventually leading to damage to trim piece and/or microwave oven door. Adjustment of shelf tracks, microwave oven and/or trim piece is necessary for proper repair. Recommend contacting a qualified appliance and/or cabinet contractor for repairs as necessary prior to close to prevent damage to microwave oven door and/or trim piece.**

Trim piece around microwave oven is not installed properly Cabinet trim piece is installed unevenly and loose around microwave oven
